Demolition Asbestos Survey
Empty Unit
Ron Skinner & Sons
Tredegar NP22 3AA

Survey undertaken by Steve Ingram
Care Environmental Surveying Limited

Survey Undertaken: 14th June 2024
Report Completed: 26th June 2024

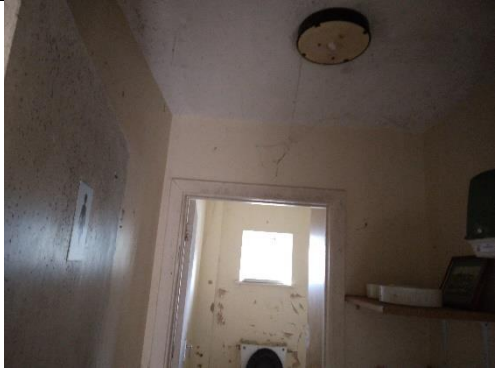
Asbestos Register & Risk Assessment											
Unit 25 Ty Verlon Industrial Estate Barry CF63 2BE											
Location /Description	Photograph	Sample ref /Presumed	Licensed?	Quality	Access	Product	Condition	Surface	Asbestos Type	MRA Score	Comments / Recommendations
Female W/C – Textured Coating to ceiling.

S001	No	6m ²	Easy	0	0	0	NAD No asbestos detected in sample	0	No action required
Male W/C – Textured Coating to ceiling

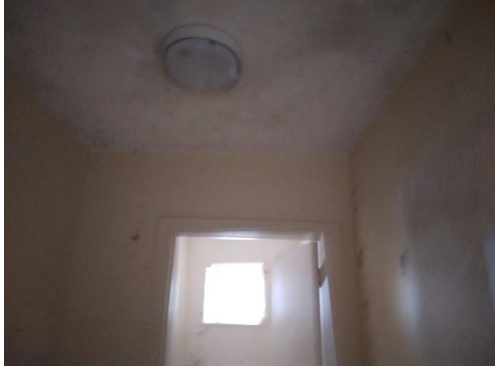
S002	No	6m ²	Easy	0	0	0	NAD No asbestos detected in sample	0	No action required

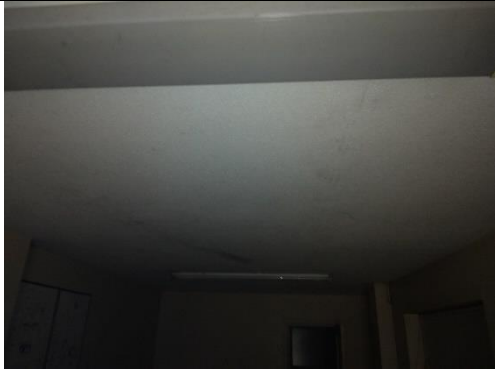
Office 1 – Textured Coating to ceiling

S003	No	15m ²	Easy	0	0	0	NAD No asbestos detected in sample	0	No action required
Office 2 – Textured Coating to	PHOTOGRAPH NOT AVAILABLE	S004	No	15m ²	Easy	1	0	2	NAD No asbestos detected in sample	0	No action required

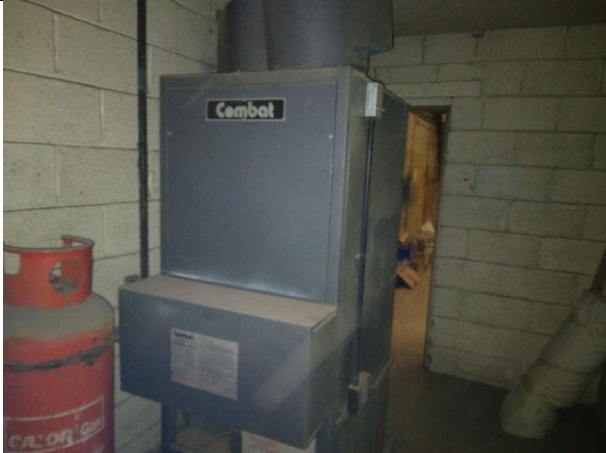
Areas not accessed			
Location / Description	Photograph	No Access	Comments / Recommendations
Main Warehouse / Heater Unit and flue.outlet.

Presumed to contain asbestos material - Live at time of survey	Dispose as asbestos containing waste in accordance with Hazardous Waste Regulation 2015 or re inspect when isolation certification is available.
Entrance Corridor / Electrical Switchgear.	PHOTOGRAPH NOT AVAILABLE	Presumed to contain asbestos material Live at time of survey	Dispose as asbestos containing waste in accordance with Hazardous Waste Regulation 2015 or re inspect when isolation certification is available.
