**10 GROUND ENGINEERING****10.1 Proposed Development**

- 11.1.1 Tweedie Evans Consulting Ltd (TEC) has been appointed by Supporta Bay Associates on behalf of Messrs Webber & Hill Family to undertake a preliminary geo-environmental and geotechnical assessment of a site off Coverack Road, Newport. All works were undertaken in accordance with our proposal letter dated 25<sup>th</sup> March 2008 and referenced 0803007.001(rev1).

**Coverack Road, Newport**

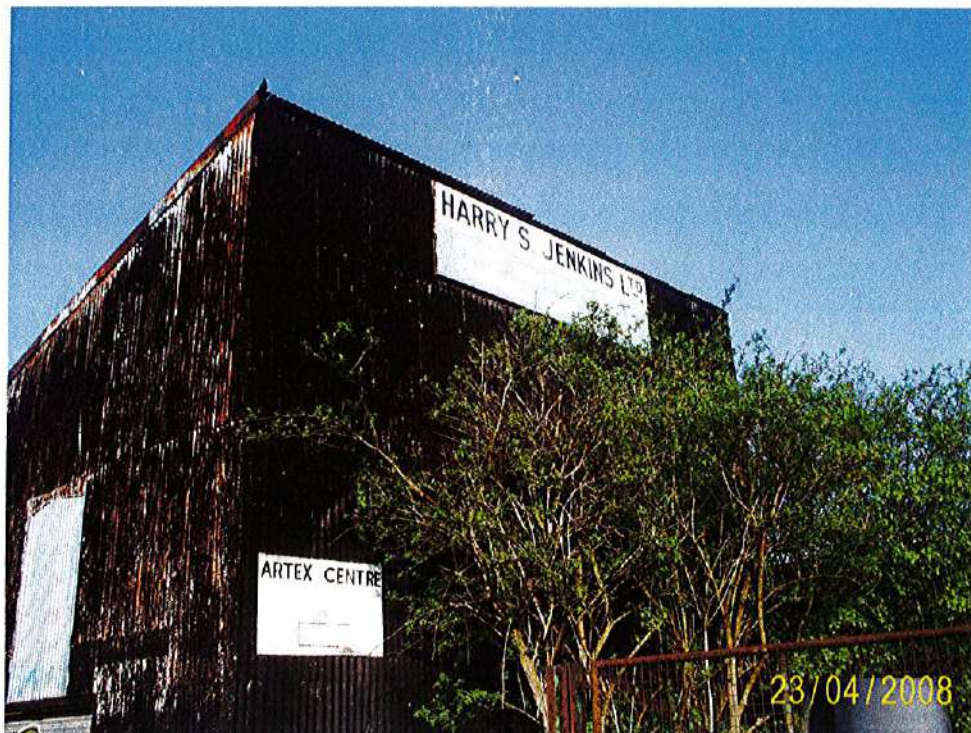
Photograph 1: Photograph of derelict building located in the north-eastern section of the site, taken from Coverack Road. Photograph shows signage indicating historic land use (Paint & Putty Works).

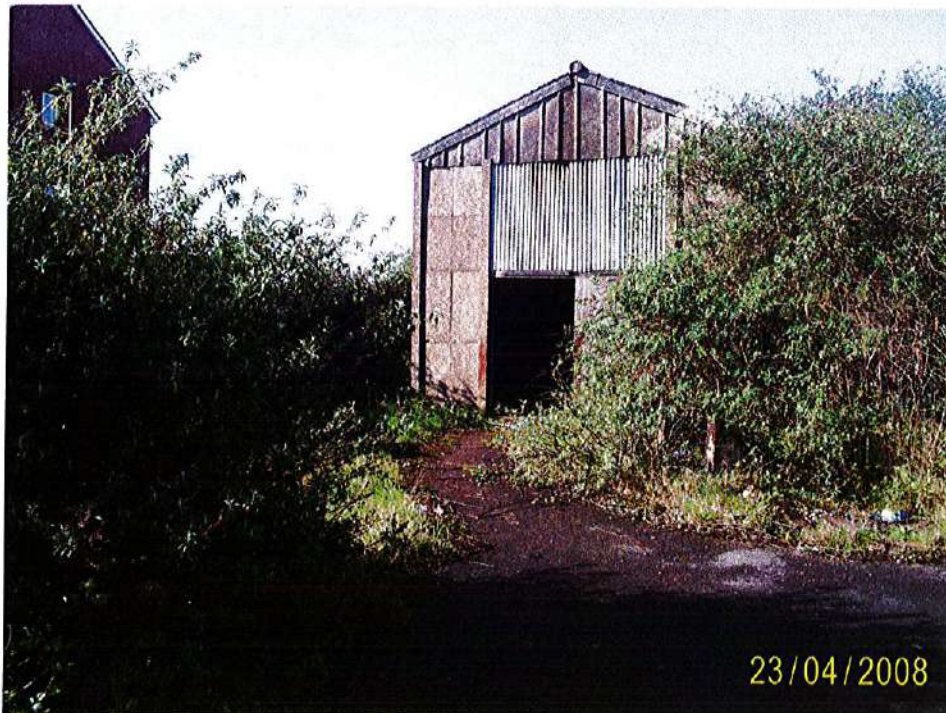
Photograph 4: Photograph showing derelict building in south-eastern section of the site. Concrete tank supports (location of TP1) visible within overgrown vegetation in right of photograph.

10.2.2 There is evidence of numerous above ground storage tanks located across the site both outside and within the derelict buildings. Concrete mounts for at least four above ground storage tanks (ASTs) were observed around the site area. Within the derelict buildings evidence of further ASTs were observed including a large tank constructed on a brick base, located in the building located in the southernmost corner of the site. Consideration should be given to these structures when planning the demolition works. Furthermore, it is considered that no significant below ground obstructions would be present at the site.

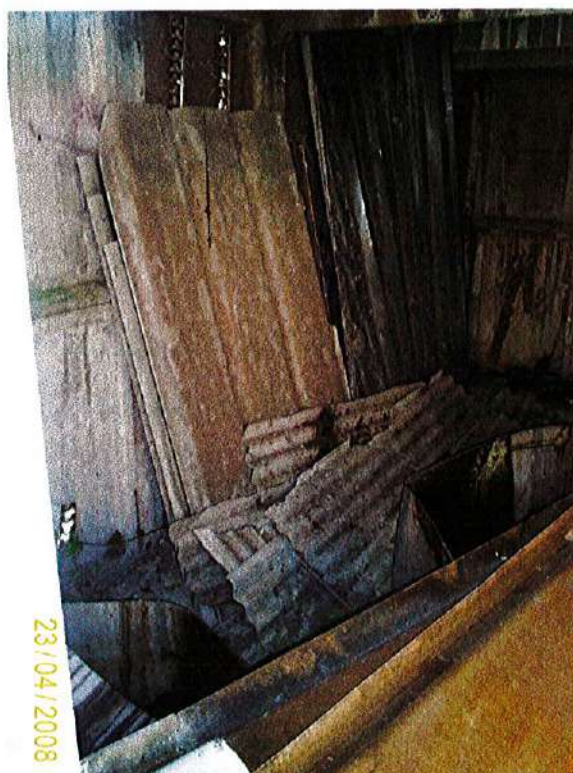
Photograph 6: Photograph showing potential ACM within derelict building in southern section of the site.

10.2.5 Evidence of Asbestos Containing Materials (ACM) was observed on site and concrete bound asbestos roofing sheets were observed stored within one of the derelict buildings. The disposal of ACM should be considered when preparing the site for development.

- Asbestos - Concrete bound asbestos roofing sheets and numerous sheets were observed on site. However, short term exposure to the ACM is not considered likely to cause significant harm to construction workers, provided that appropriate health and safety procedures are in place. No ACM was observed within the encountered ground materials on site.

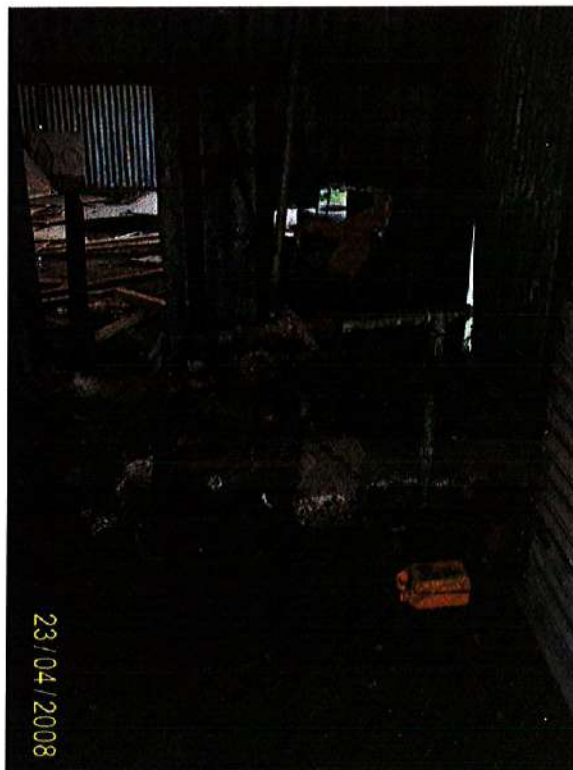
Photograph 8: Photograph showing pipework and possible base for AST within the derelict building located in the north-eastern section of site. Staining of concrete clearly visible.

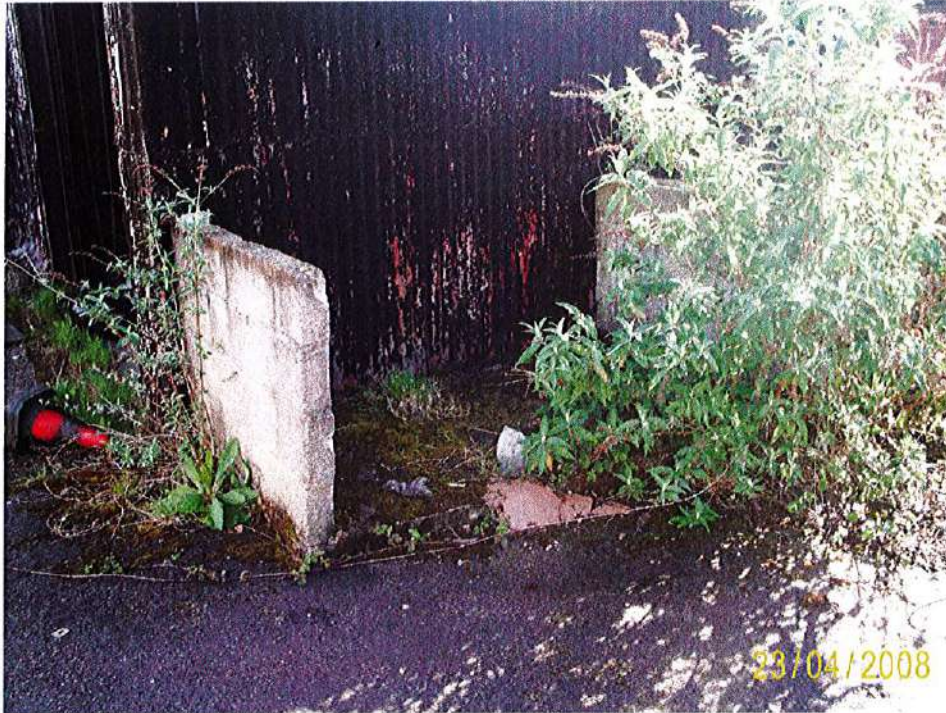
Photograph 9: Photograph showing location of TP2, at location of historic AST.

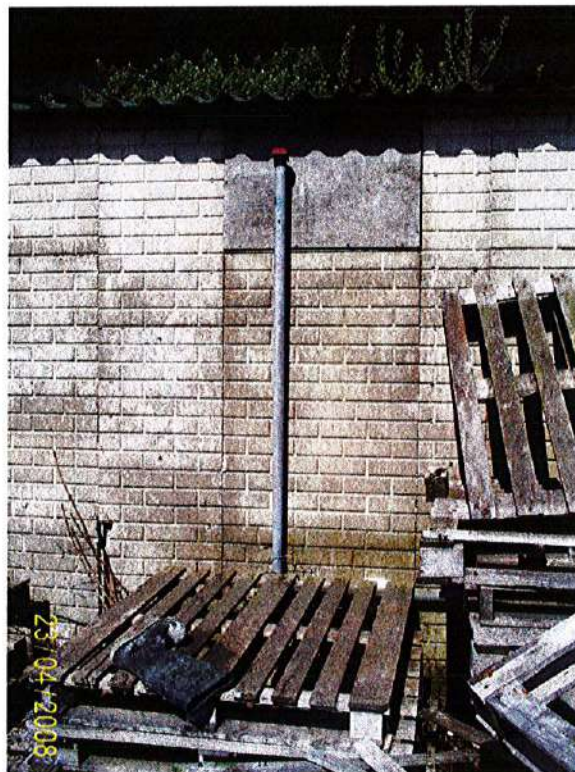
Photograph 10: Photograph showing a potential venting pipe located on building in north-western section of the site.

10.2.3 A pipe was observed to run along the northern boundary of the site from the building located in the north-eastern section of the site. The pipe traverses the northern part of the site and aligns vertically at the building located in the north-western section of the site. It is presumed this feature is a venting pipe. Consideration to this feature should also be given when the demolition of the site is planned.

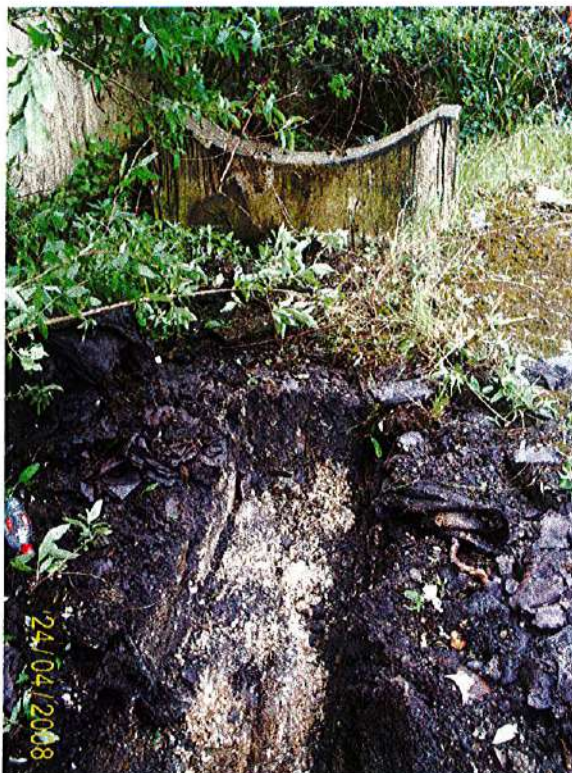
- 10.3.4 Within TP4, was undertaken in vicinity of a historic AST in the southern section of the site. Dark brown to black sandy gravel of brick, concrete, clinker and plastic was observed to 0.2m depth. In addition, cardboard and textiles were observed within these materials. Underlying the initial surface layer, light brown to cream-brown slightly gravelly to gravelly clay was observed to 0.65m depth. The gravel encountered comprised medium to coarse sized fragments of moderately weak to strong chalk with occasional to rare flint. Between 0.65m and 1.5m depth, gravel to cobbles of red-brown and orange-brown black stained sandstone was observed.

Photograph 11: Photograph showing location of TP4, within southern section of the site. Blackened near surface materials visible in foreground and concrete supports for AST visible in background.

- 11.3.4 An area of hydrocarbon contamination is considered to exist in the western part of the site (TP4), where elevated PAH and TPH concentrations indicate a significant risk through ingestion and dermal contact.

- 11.3.5 Although the hydrocarbons encountered were within the heavier, less volatile ranges, significant olfactory (TP4 only) evidence was recorded during investigations and, as such, the potential risk from vapours cannot be discounted. While further investigation would be required to determine the extent of the hydrocarbon contamination at this location and to better quantify the risk posed, consideration should be given at this stage to the inclusion within the design of a suitable vapour barrier. Further assessment would be required in order to determine the risk posed to human health from the identified hydrocarbon contamination.

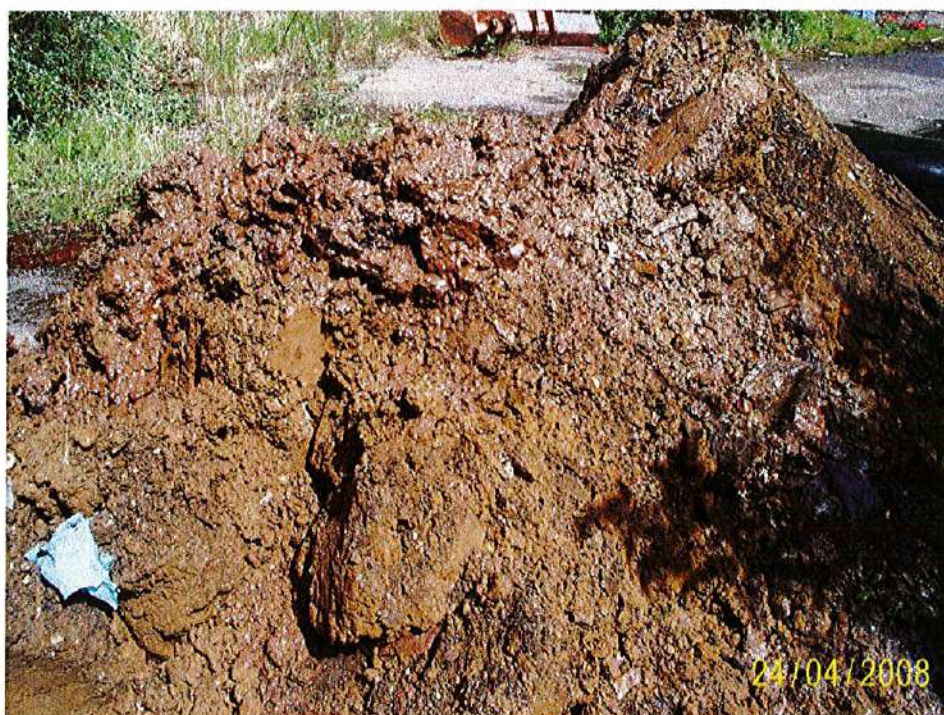
- 10.3.7 Visual and olfactory evidence of hydrocarbon contamination was observed within TP4 in the materials recovered between 3.9m and 4.40m depth.
- 10.3.8 Laboratory analysis was conducted on four samples of the possible made ground/natural ground. The results of these analyses are presented in Table 10.1 below.

Photograph 12: Photograph showing arisings from TP4, materials with hydrocarbon sheen visible on top of spoil heap.

11.3.12 It is recommended that groundwater samples are obtained from the perched water overlying the alluvium and risk assessment is undertaken, in order to establish the potential harm to controlled waters from the identified contamination on site.

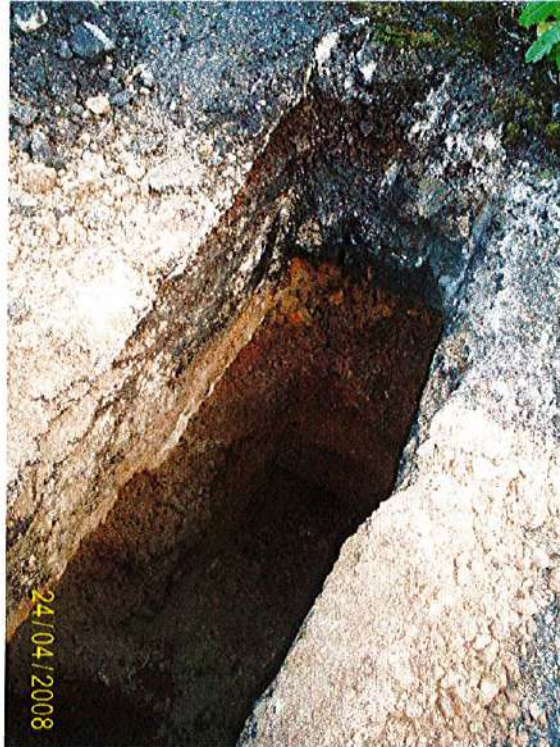
Photograph 13: Photograph showing materials within TP2.

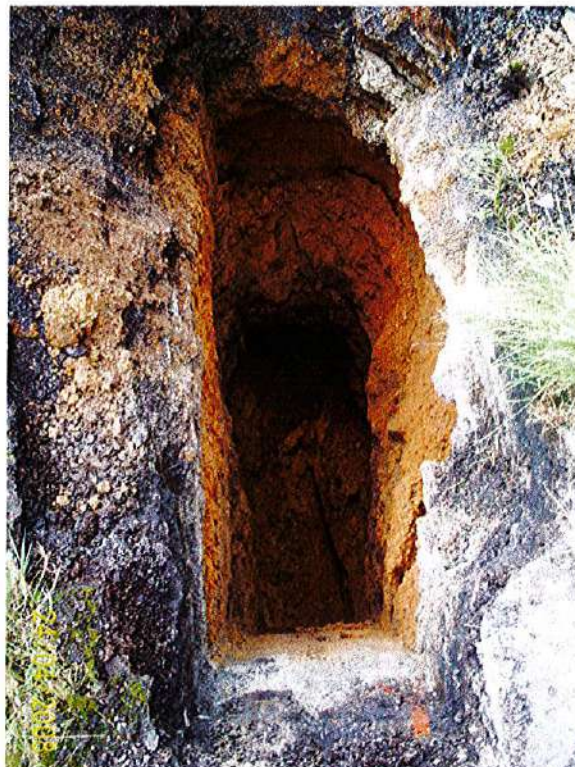
Photograph 14: Photograph showing materials within TP5. Darkened made ground materials visible at near surface.

- 11.3.6 It should be noted that olfactory evidence of hydrocarbon contamination was also observed within the shallow made ground encountered at TP1, TP5

and TP6 (areas of historic ASTs), but no TPH analysis was undertaken to confirm the presence of hydrocarbons at these locations. Therefore, it is recommended that further intrusive works are undertaken at these locations in order to assess the extent of such potential contamination.
