Arboricultural Report

Date – 4th November 2024

Site – Crymlyn Parc, Skewen

Project Reference – ArbTS_1945.3_Crymlyn Parc

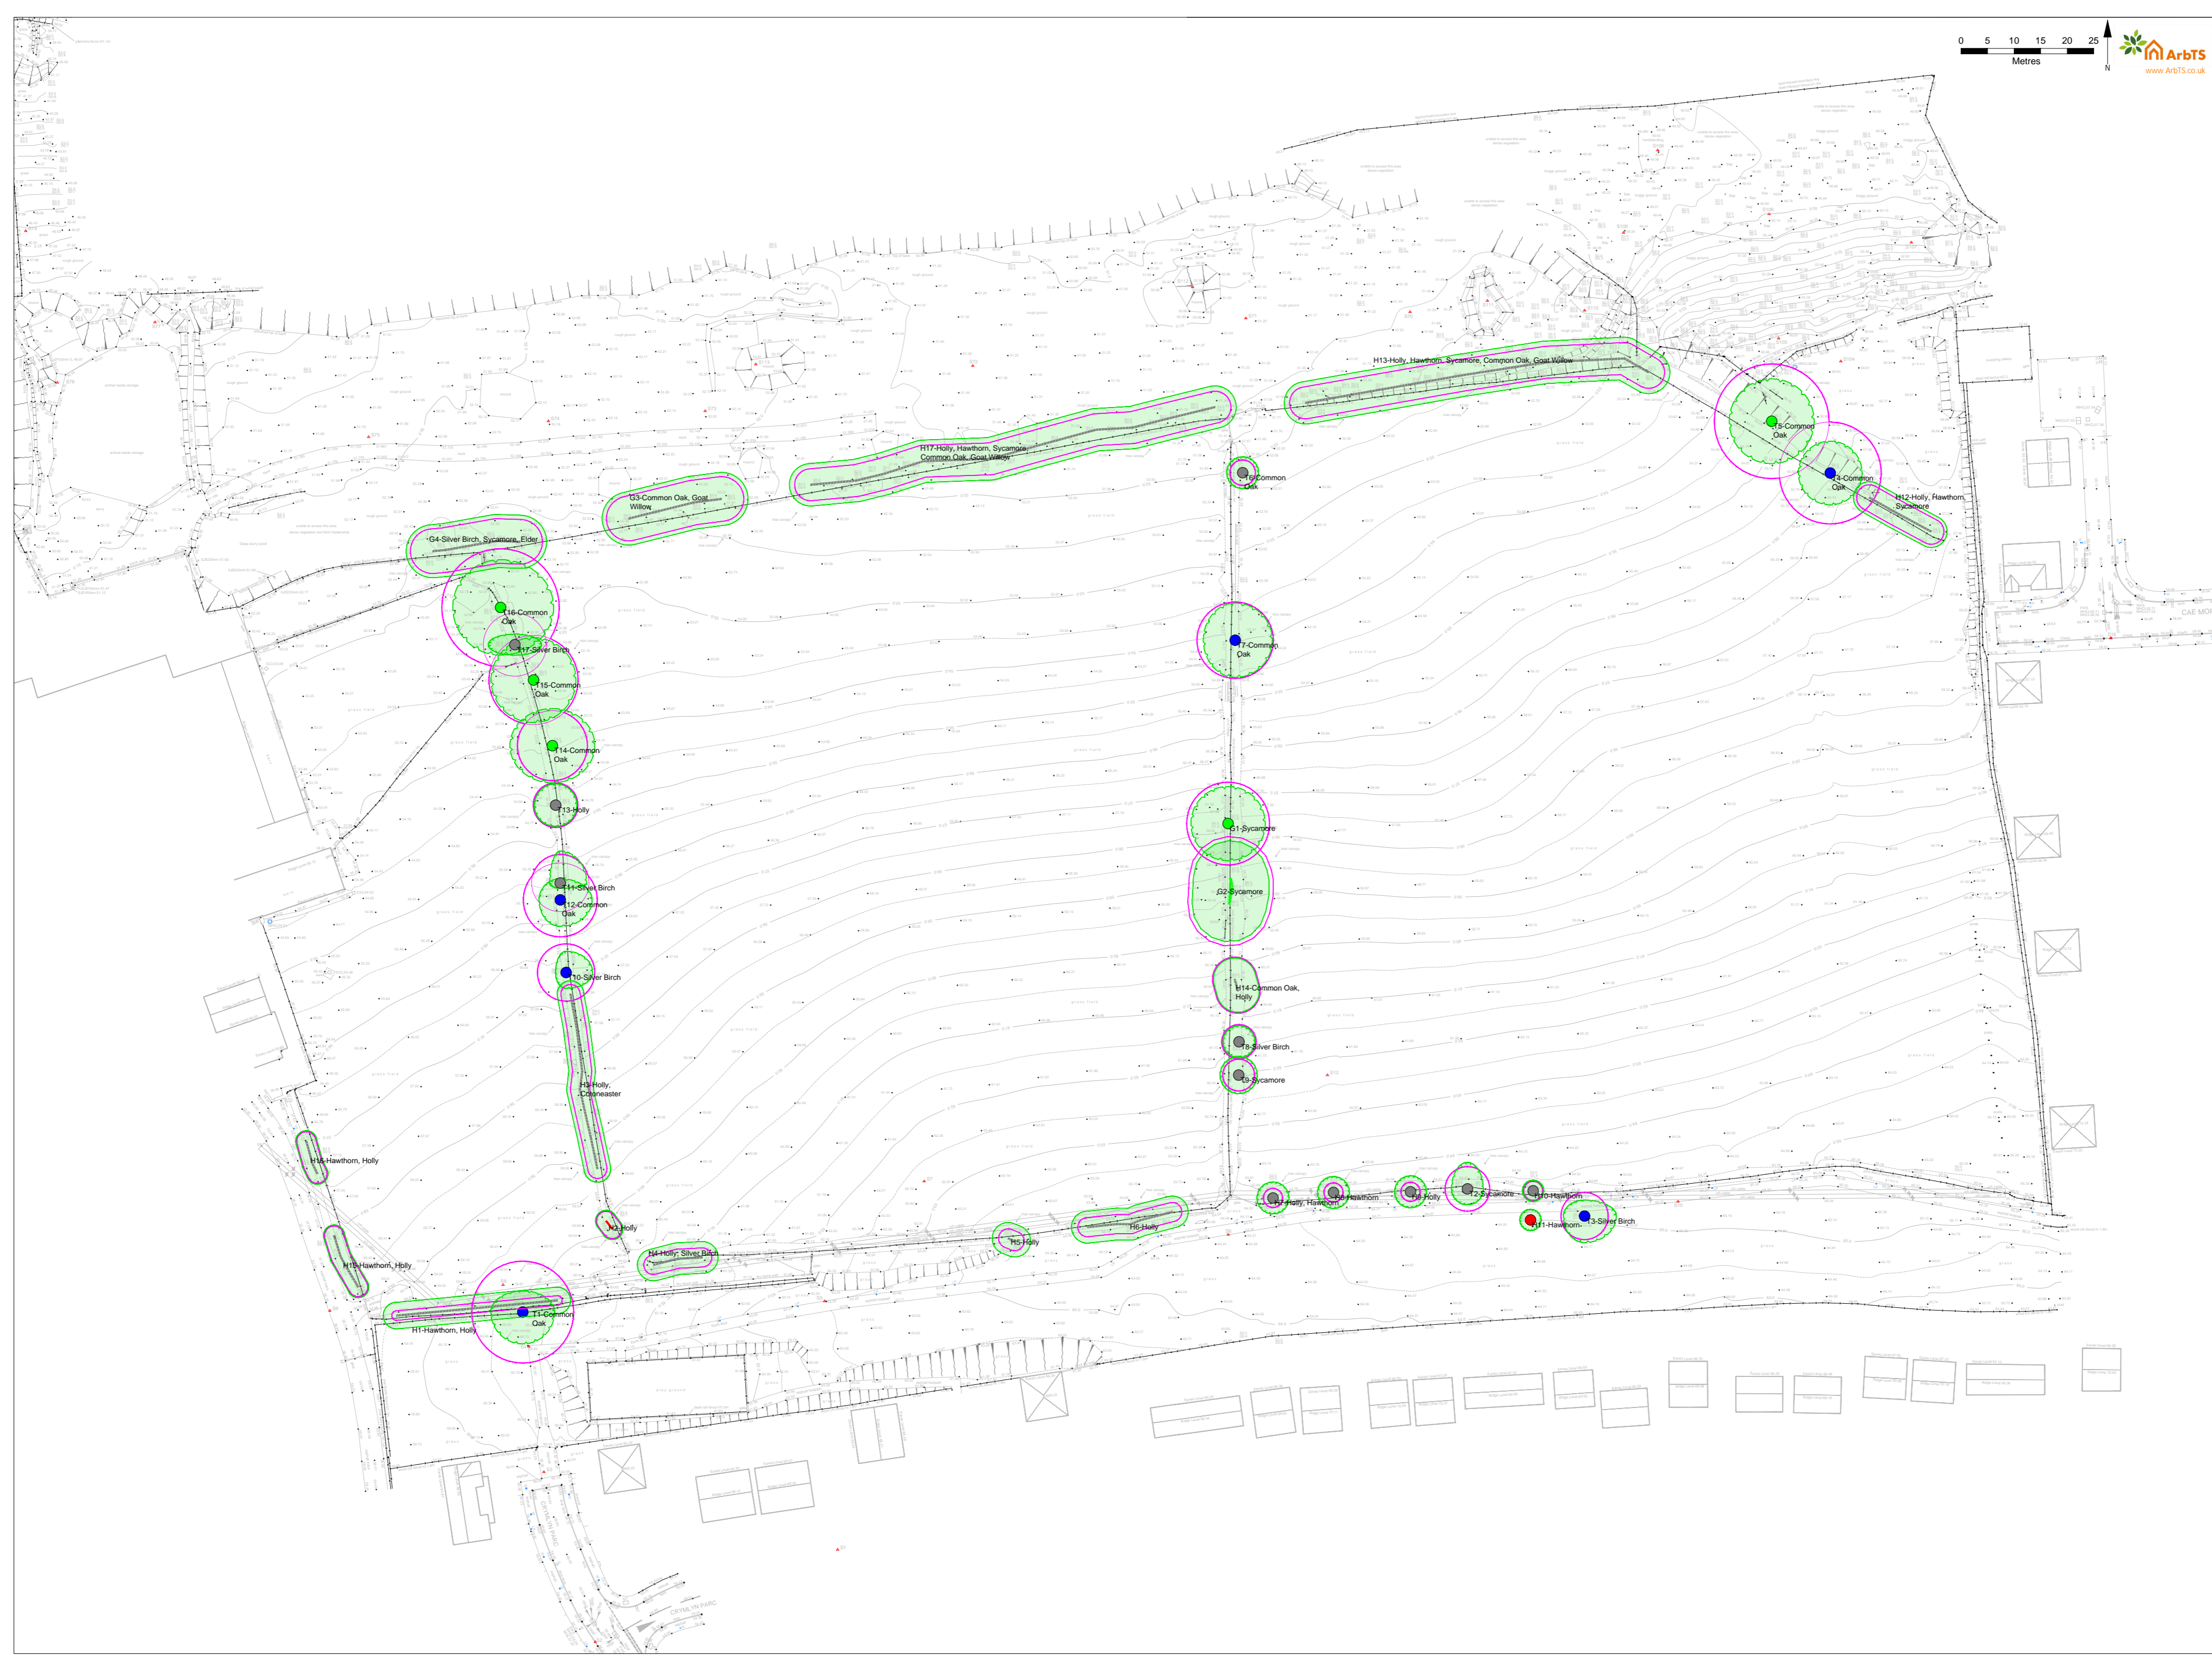
10.0 Appendix 2 - Tree Constraints Plan

- **Tree Quality** - The TCP highlights the above and below-ground constraints each tree poses to design future development schemes. Further, the BS5837 tree quality category (A - High, B - Moderate, C - Low and U- Unsuitable for retention) are coloured coded as solid circles at the centre of the tree's position.

- **Root Protection Area** – The magenta circle on the TCP sets out the root protection area (RPA). No construction work in this area, ground-level alteration or site traffic (machinery or persons) should occur. This prevents damage to tree roots and soil compaction. (Where possible, an Arboriculturist can design suitable tree protection methods to facilitate construction work/site traffic within these areas).

- **Tree Canopy** - The green circle/oval on the TCP sets out the above-ground constraints of tree canopy spread. Within this area, no construction work or site traffic (machinery or persons) should occur if the tree is to be retained. This prevents damage to the tree branches and trunk. (Where possible, an Arboriculturist can design suitable tree protection methods to facilitate construction work/site traffic within these areas).

- 4.1 A Tree Constraints Plan (TCP) can be found in Appendix 2 of this report. An introduction to TCP can also be found at the start of this Appendix Section. For further information and details regarding TCP, please see the *British Standard 5837:2012, Trees in relation to design, demolition and construction – Recommendations*.

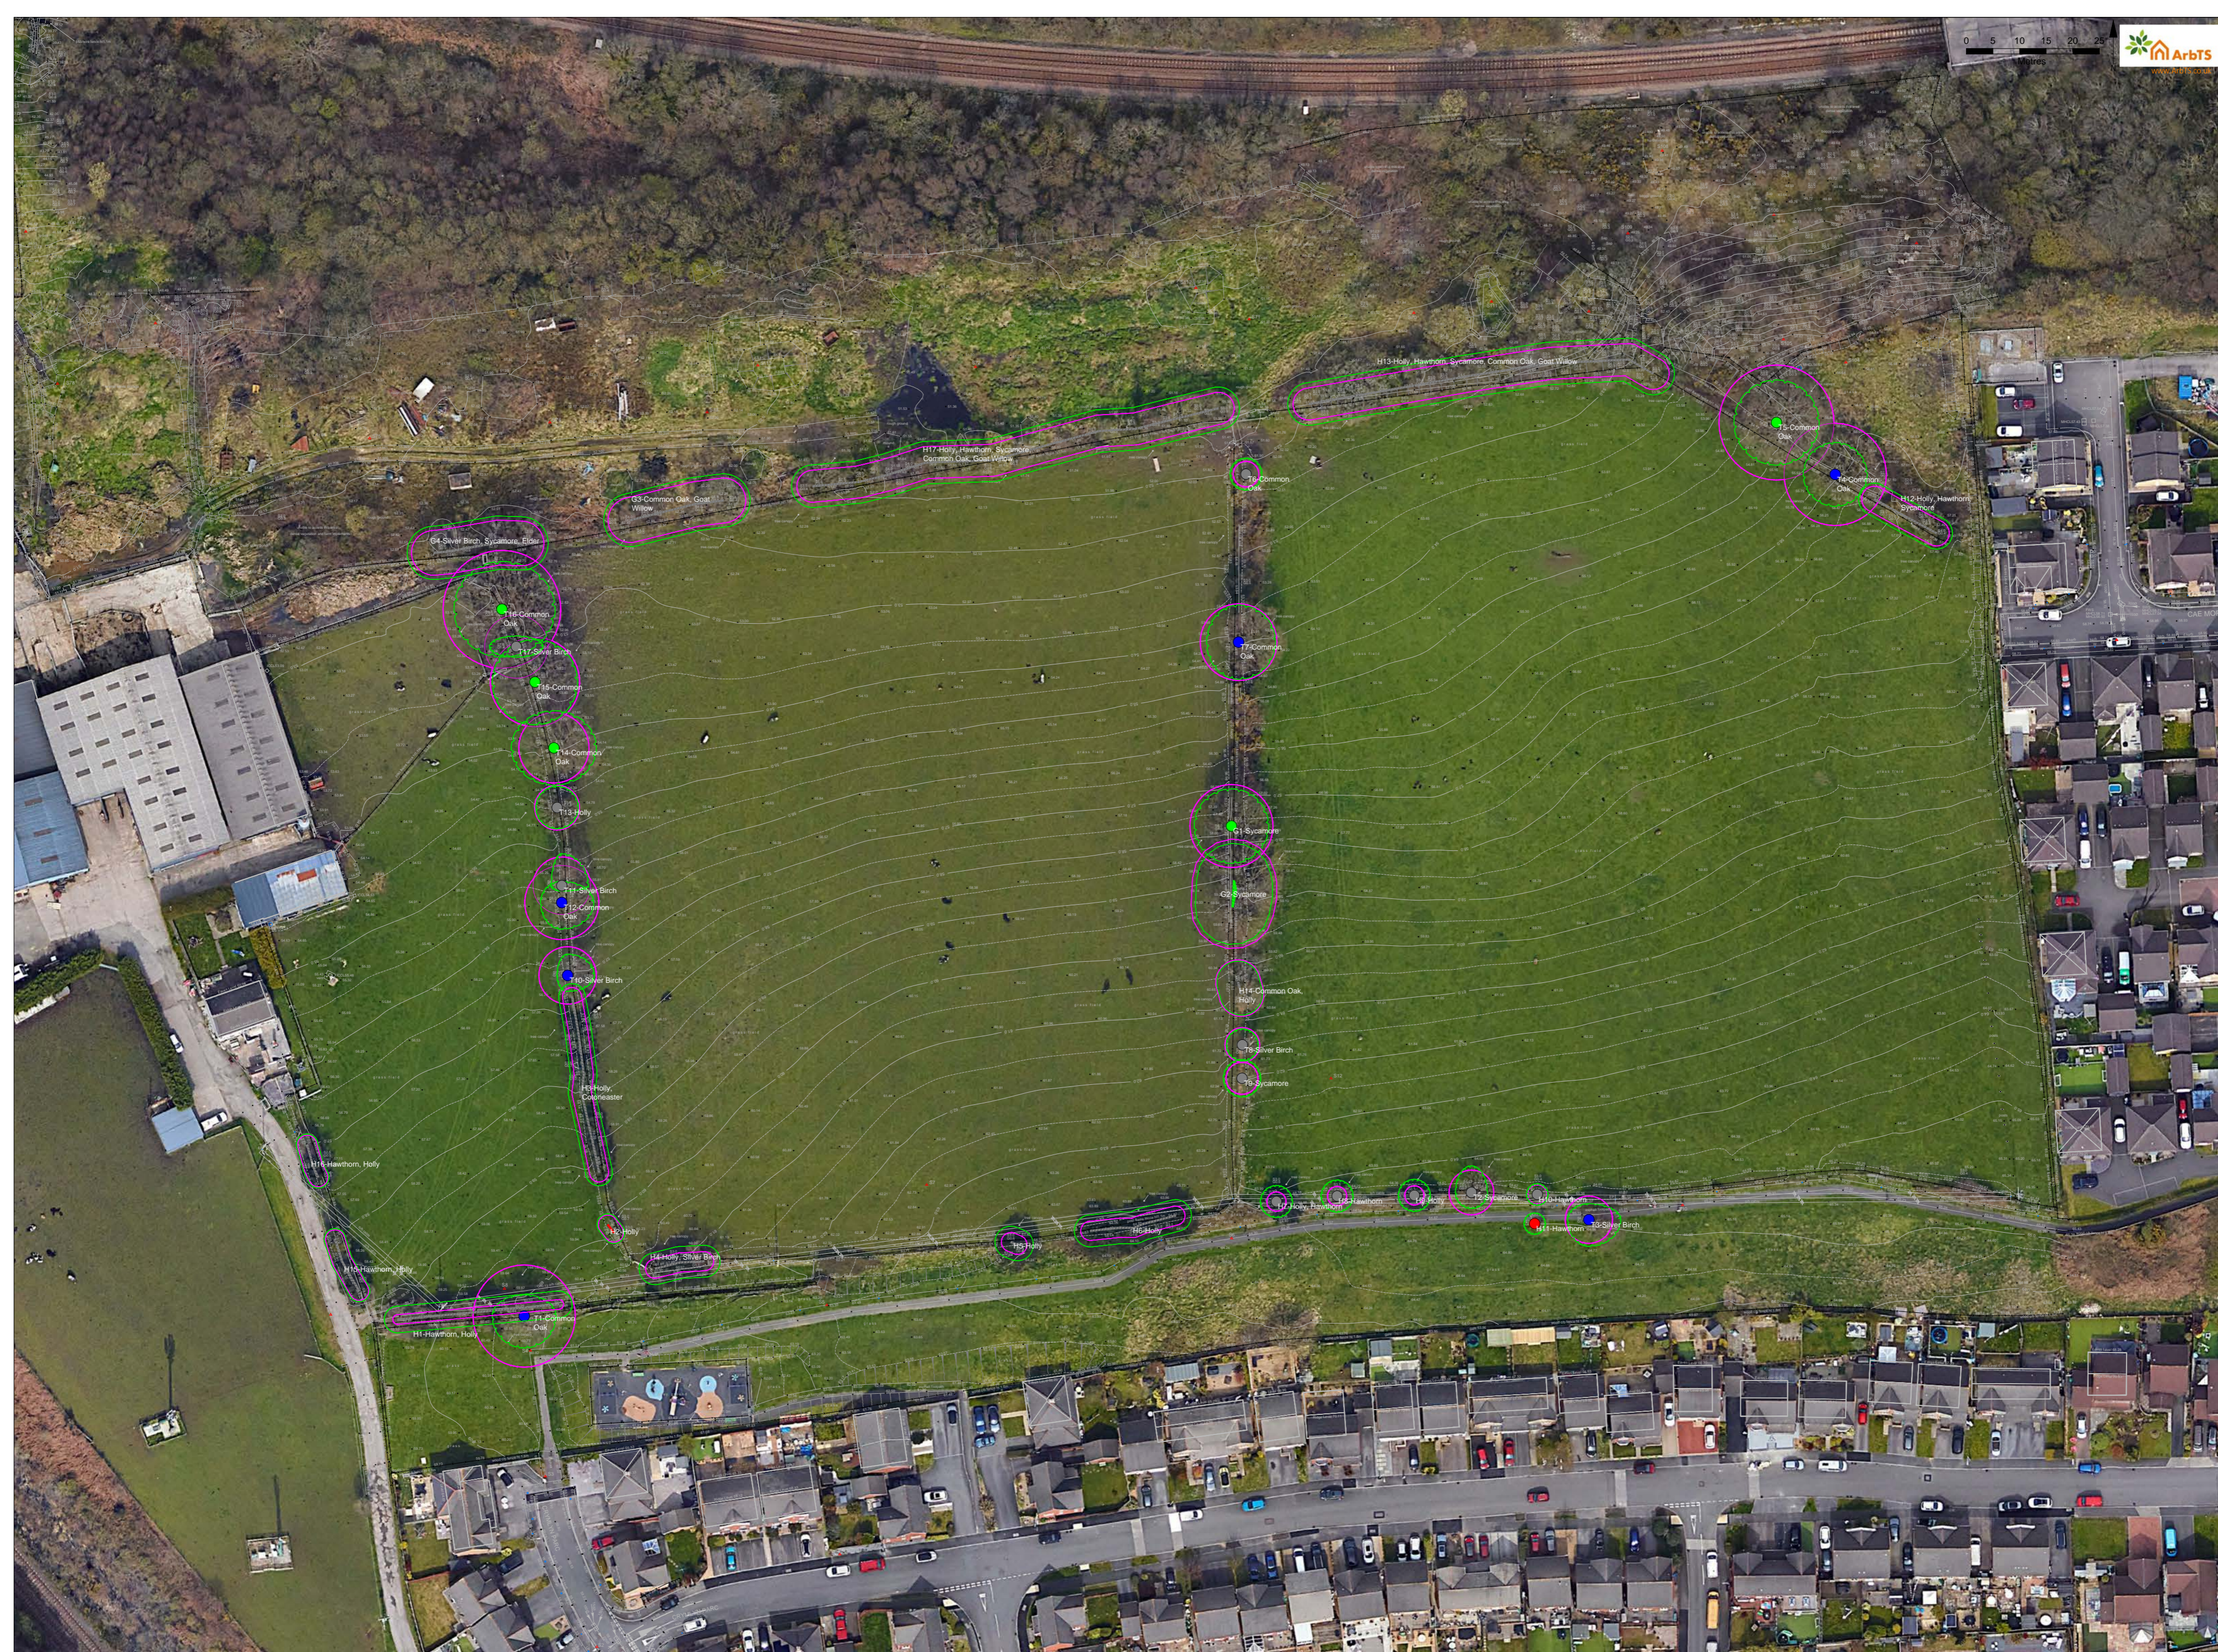
H17-Holly, Hawthorn, Sycamore, Common Oak, Goat Willow

G3-Common Oak, Goat Willow

Please Note:
Barriers and Ground Protection must be designed by an arboriculturist, installed before materials or machinery is brought onto site and before any demolition, development or stripping of soil commences. Once erected, barriers and ground protection should be regarded as sacrosanct, and should not be removed or altered without prior recommendation by an Arboriculturist and approval of the Local Planning Authority (LPA).

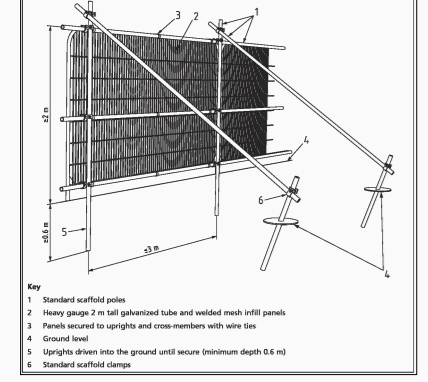
The fencing will comprise of standard GS7/Hexas styled steel self-supporting security fencing panels. The panels must be securely clamped together. They must be secured to the ground with robust steel stakes to a depth of 600mm. These are securely clamped to the panels. The use of steel mesh panels in conjunction with just clamps and self supporting bases is not acceptable for use. They must be secured to the ground with stakes to prevent movement. Where stated, additional bracing of the panels must use angled scaffolding poles to prevent further movement (see diagram).

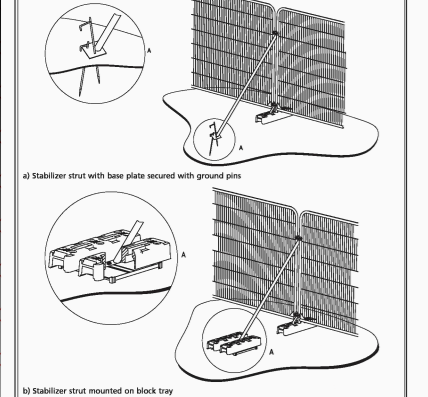
For example: 2metre tall welded mesh panels on rubber or concrete feet might provide an adequate level of protection from cars, vans, pedestrians and manually operated plant. In such cases, the fence panels should be joined together using a minimum of two anti-stamper couplers, installed so that they can only be removed from inside the fence. The distance between the fence couplers should be at least 1 m and should be uniform throughout the fence. The panels should be supported on the inner side by stabilizer struts, which should normally be attached to a base plate secured with ground pins. Where the fencing is to be erected on retained hard surfacing or if it is otherwise unfeasible to use ground pins, a due to the presence of underground services, the stabilizer struts should be mounted on a block tray. (See Diagram Below)

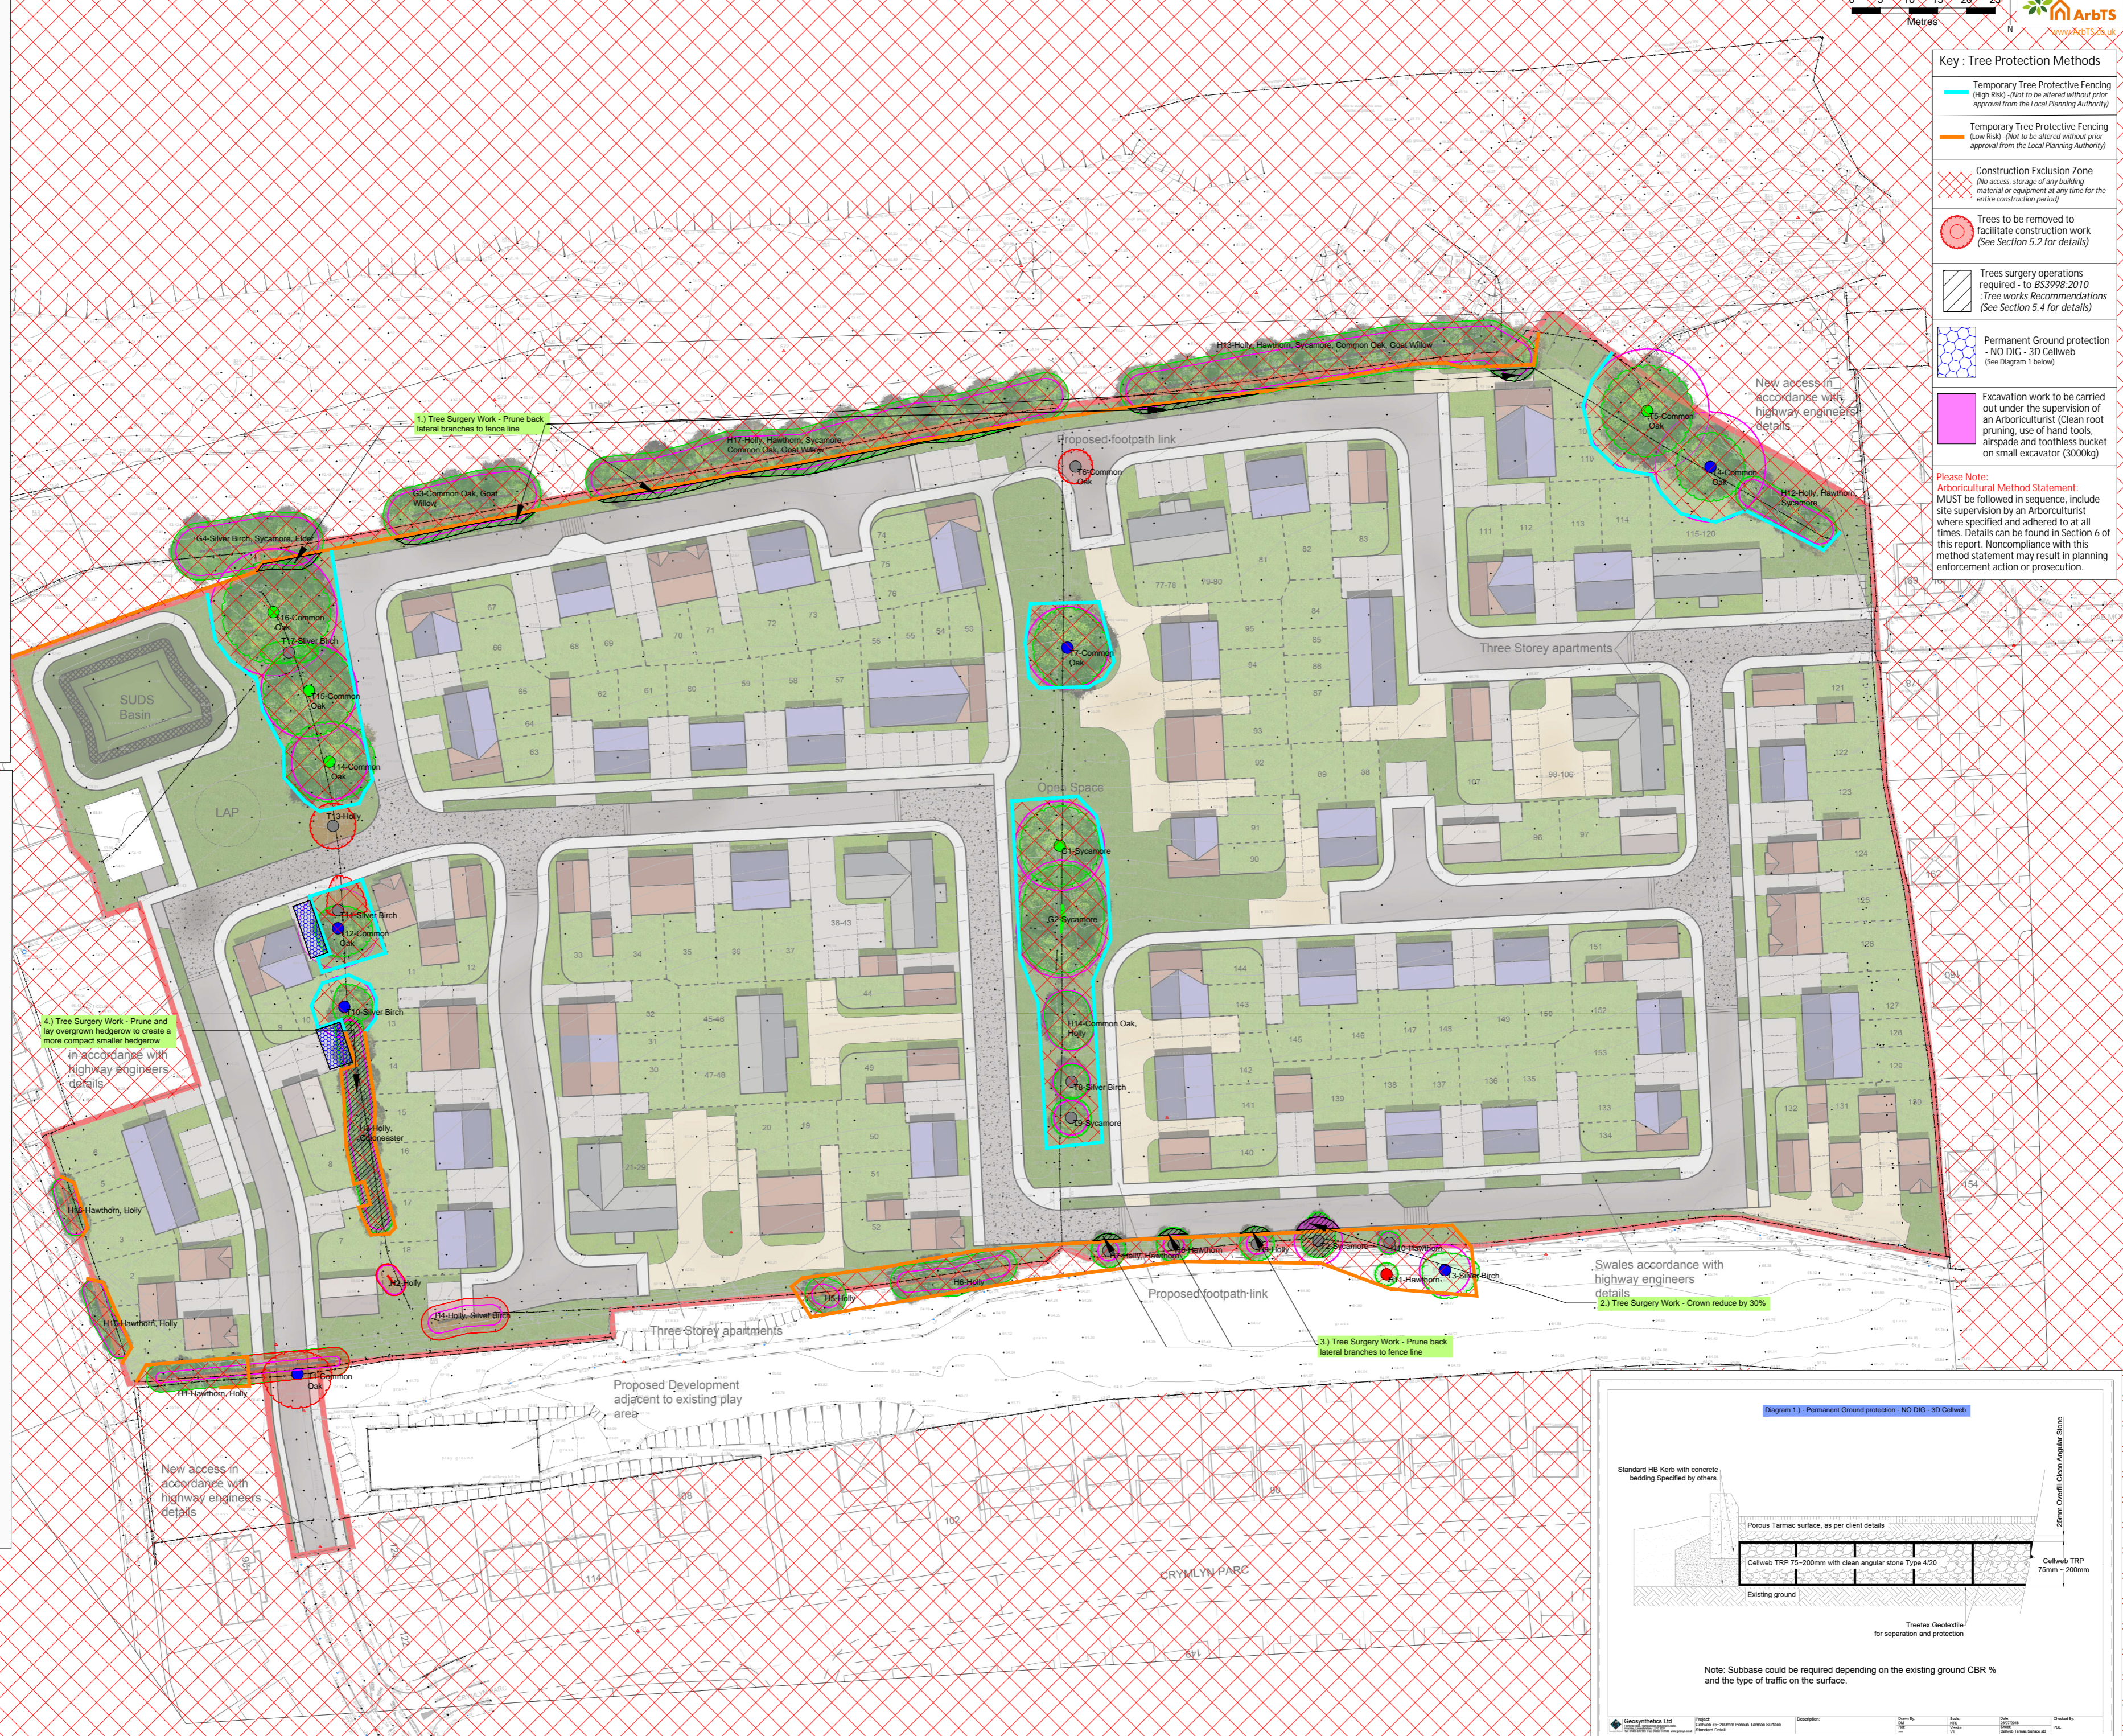
- #### Key: Tree Protection Methods
- Temporary Tree Protective Fencing (High Risk) - (Not to be altered without prior approval from the Local Planning Authority)
 - Temporary Tree Protective Fencing (Low Risk) - (Not to be altered without prior approval from the Local Planning Authority)
 - Construction Exclusion Zone (No access, storage of any building material or equipment at any time for the entire construction period)
 - Trees to be removed to facilitate construction work (See Section 5.2 for details)
 - Trees surgery operations required - to BS3998:2010 (Tree works Recommendations (See Section 5.4 for details)
 - Permanent Ground protection NO DIG - 3D Cellweb (See Diagram 1 below)
 - Excavation work to be carried out under the supervision of an Arboriculturist (Clean root pruning, use of hand tools, airspade and toothless bucket on small excavator (3000kg))

- 6.1 The Tree Protection Plan to facilitate the construction of the development design can be found in Appendix 4 of this report. The Tree Protection Plan must comply with all of the following:
- Be regarded as sacrosanct and follow the sequence of events as detailed in the table below
 - Be installed before commencement of any demolishing or construction works on site
 - Must not be removed or altered without prior approval of the local planning authority
- 6.2 The following table overleaf provides a detailed sequence of events that must occur to protect the retained trees during all stages of the construction process. These methods must be communicated to the entire construction team before any work on site.

1.4 – Tree protective fencing installed in the position and form as detailed in the Tree Protection Plan (Appendix - 4). Installation is to be supervised by the appointed Arboriculturist. All weather tree construction exclusion zone posters are to be secured to fencing at regular intervals.

<p>1.5– No DIG Cellweb permanent ground protection installed as designed by the manufacturer, detailed in the Tree Protection Plan (Appendix 4). Installation is to be carried out by an experienced and qualified contractor and additionally supervised by the appointed Arboriculturist.</p> <p>1.6 – Site storage area containers installed as designed and supervised by the site supervisor and the appointed Arboriculturist.</p> <p>1.7– Onsite meeting with all parties, client, Local Planning Authority tree officer, agent, developer, site supervisor and the appointed Arboriculturist to ensure all tree protection methods are in place as detailed on the Tree Protection Plan (Appendix - 4). Any issues that arise from the site meeting are addressed if required.</p> <p>1.8 – Appointed Arboriculturist to document all tree protection methods in situ and photographs taken for reference purposes. Copy of document report sent to all parties.</p>

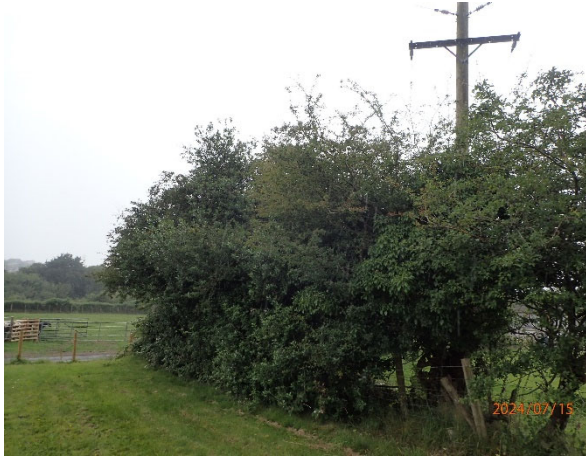
Tree ID#H1

- Hedgerow H1 – Length 17 metres - Low quality (C category)
- Hedgerow H2 – Length 3 metres - Poor quality (U category)
- Hedgerow H3 – Length 9 metres - Low quality (C category)

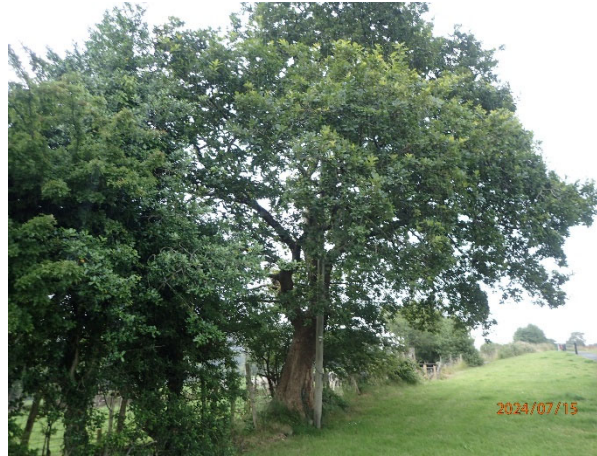
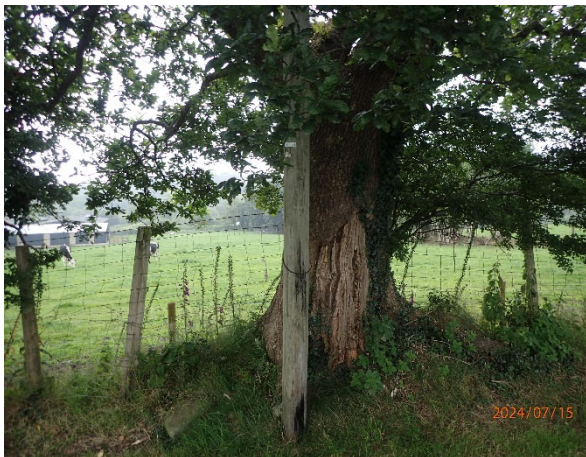
Tree ID#T1

- T1 – Oak - Moderate quality (B category) – T1 is a mature boundary oak tree that is assessed to be at the lower end of the B Category classification. This is because it has been repeatedly pruned back from the above electrical lines and has some internal decay of the main trunk. T1 is to be removed to create one access point into the site as defined in the adopted LDP where two access points are required.

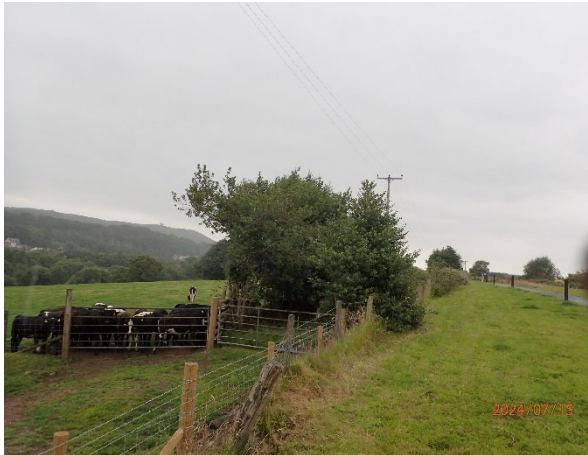
Tree ID#H4

H4	Ilex aquifolium (Holly), Betula pendula (Silver Birch)	EM	1	150	C2	4(1)	3	3	3	3	F	F	10+		section of elapsed managed hedgerow, appears to have had animal damage		1.8	10.18
H5	Ilex aquifolium (Holly)	EM	1	150	C2	4(1)	3	3	3	3	G/F	N/A	10+	Surrounding vegetation prevented close inspection of the tree therefore all observations and measurements are estimated.	section of overgrown hedgerow		1.8	10.18
H6	Ilex aquifolium (Holly)	EM	1	150	C2	4(1)	3	3	3	3	G/F	N/A	10+	Surrounding vegetation prevented close inspection of the tree therefore all observations and measurements are estimated.	section of elapsed managed hedgerow		1.8	10.18
H7	Ilex aquifolium (Holly), Crataegus monogyna (Hawthorn)	EM	1	150	C2	4(1)	3	3	3	3	G/F	N/A	10+	Surrounding vegetation prevented close inspection of the tree therefore all observations and measurements are estimated.	section of elapsed managed hedgerow		1.8	10.18

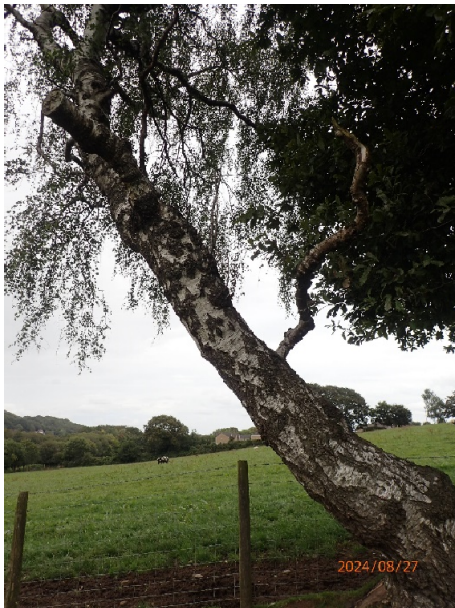
Tree ID#T11

- T11 – Small Silver Birch – Low quality (C category)
- T6 – Small Oak – Low quality (C category)

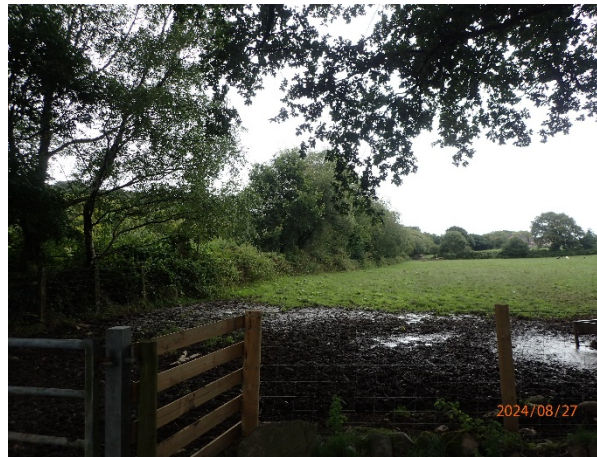
Tree ID#G3

G3	Quercus robur (Common Oak), Salix caprea (Goat Willow)	M	1	350	C2	9(2)	5	5	5	5	F	N/A	10+	Surrounding vegetation prevented close inspection of the tree therefore all observations and measurements are estimated.	small group of boundary trees		4.2	55.42
G4	Betula pendula (Silver Birch), Acer pseudoplatanus (Sycamore), Sambucus nigra (Elder)	M	1	350	C2	8(2)	5	5	5	5	F	N/A	10+	Surrounding vegetation prevented close inspection of the tree therefore all observations and measurements are estimated.	small to medium boundary tree group		4.2	55.42
H1	Crataegus monogyna (Hawthorn), Ilex aquifolium (Holly)	EM	1	75	C2	3(0)	2.5	2.5	2.5	2.5	G/F	G/F	10+				0.9	2.55
H2	Ilex aquifolium (Holly)	EM	1	150	U	4(1)	2	2	2	2	P	P	<10		small section of declining hedgerow, appears to have had animal damage		1.8	10.18
H3	Ilex aquifolium (Holly), Cotoneaster frigidus (Cotoneaster)	EM	1	150	C2	4(1)	2.5	2.5	2.5	2.5	F	F	10+		section of hedgerow, appears to have had animal damage		1.8	10.18
