Bat Survey: Mitchell Court, Tonypandy, CF40 2RD

Instructed by: Trivallis

Reported by: Ecological Services Ltd
10 Mount Pleasant, Llanelly Hill, Abergavenny, Monmouthshire, NP7 0NT

Author	Date	Version
Ash Harris	June 2023	V1.0

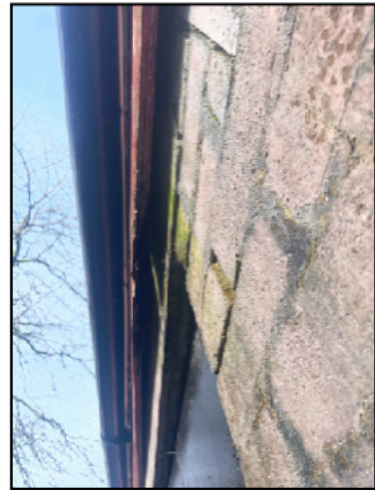
6.5 The garage building to the north west of the main residential block appeared to be generally tight with limited potential for bat use. However, some areas of the fascia were rotten and could possibly provide bat access into the building.

Areas of Raised Timber Fasciae on the Garage Block

9.6 The garage building was assessed as having very limited bat roosting potential. While two areas of rotten fascia were noted, the gaps did not appear to lead into any larger space. The corrugated metal sheet roof is also likely to suffer from temperature fluctuation during the summer months making it less suitable for bat roosting use. On balance, the garage building was assessed as having negligible potential for bat roosting use. No further bat survey work was recommended for this structure.

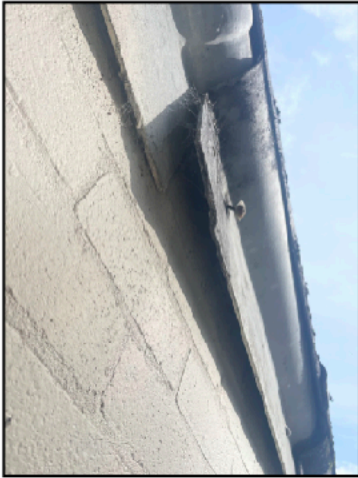
6.4 A single storey lean-to structure to the west of the main building had a small number of features which bats could possibly utilise. Apertures in the brickwork and underneath the metal sheet roof were noted along the eastern elevation.

Raised Timber Fasciae on the Lean-to Structure

9.5 The main building and lean-to structure to the west were assessed as having at least low potential for roosting bats. While only a limited number of opportunities present for bats to access and use the building were noted, the site does have good habitat connectivity to the wider landscape and the height of the building may have obscured suitable bat roosting features. As the development proposals include demolition it was advised that at least 1 bat activity survey be completed on the two buildings.

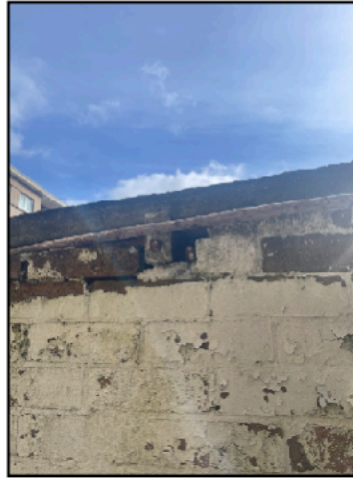
Apertures in the Brickwork on the Lean-to Structure

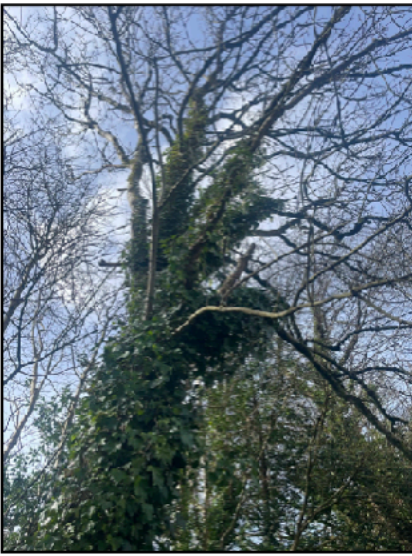
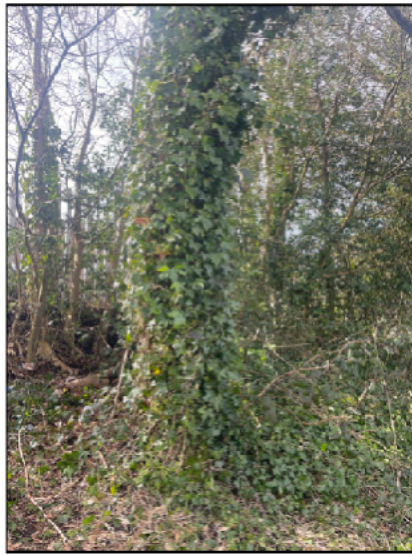
7.7 The four trees which were assessed as having low potential for bat roosting use were categorised as such due to the moderate coverage of ivy present on each tree. No other PRFs were noted during the GBVRA, however, there could be features present underneath the ivy cover. Photographs of the low potential trees are provided in Appendix 4.

<u>Low Potential Trees</u>	<u>Description of Trees</u>
T5 (Ash)	Located approximately at the west of the site. Moderate ivy coverage.
T6	Located approximately at the west of the site. Moderate ivy coverage.
T8	Located approximately at the north west of the site. Moderate ivy coverage.
T10	Located approximately at the north west of the site. Moderate ivy coverage.

9.8 Four of the twelve trees surveyed were assessed as having low potential for bat roosting use. These trees will be removed under a precautionary soft fell methodology, preferably in September/October to avoid maternity and hibernation seasons. Soft fell methodology is where the tree limbs are cut and left grounded overnight to allow any bats to make their way out.

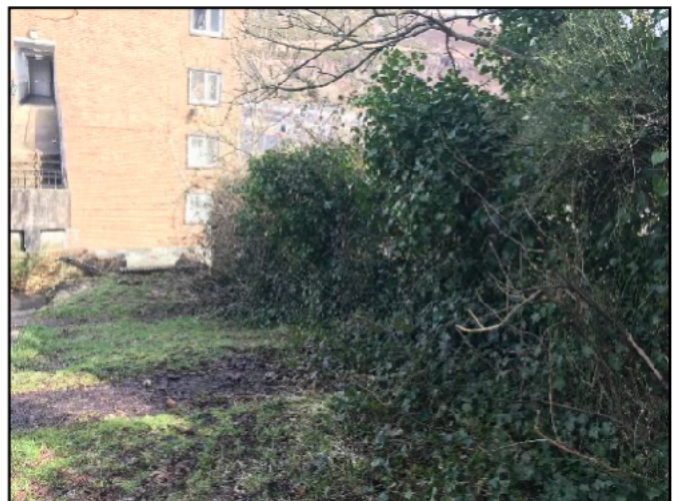
Fence & Ivy cover to south west of grassland
