BODLONDEB FORMER RESIDENTIAL CARE HOME, ABERYSTWYTH

PHASE II: GROUND INVESTIGATION INTERPRETATIVE REPORT

Report No. Q1149/IR

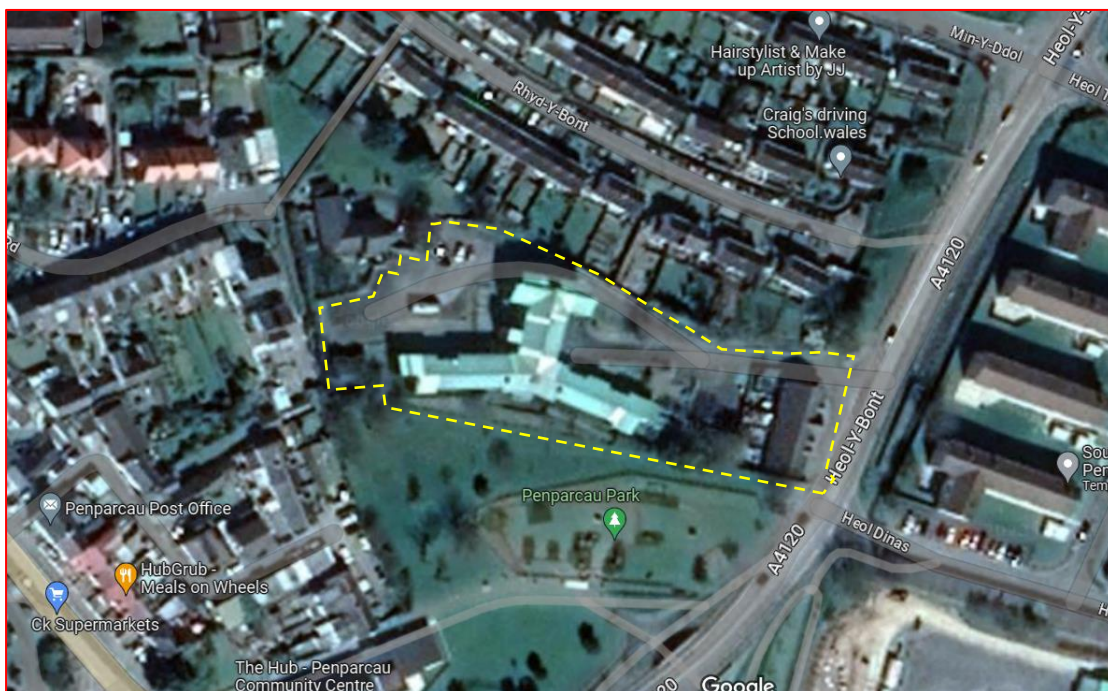
Figure 1: Current Aerial Mapping of the Site © 2023 Google Inc.

The site is bounded to the east by Heol-Y-Bont/A4120, the only access to site is off this road. Fenced off to the north are low rise residential properties. To the south is Penparcau Park which consists of green space and a playground, this is fenced off from the site. To the west of the site is residential housing which is separated from the site by fencing. In general, the site is in a residential suburban area. The approximate eastings and northings of site centre is 259256E 280170N, with a nearby postcode of SY23 1SR. The layout of the proposed development on site is indicated on the site plans presented in Appendix I. An aerial view of the site from current on-line mapping is presented below with the approximate site boundary highlighted in yellow. The site has not been visited as part of this desk study assessment.

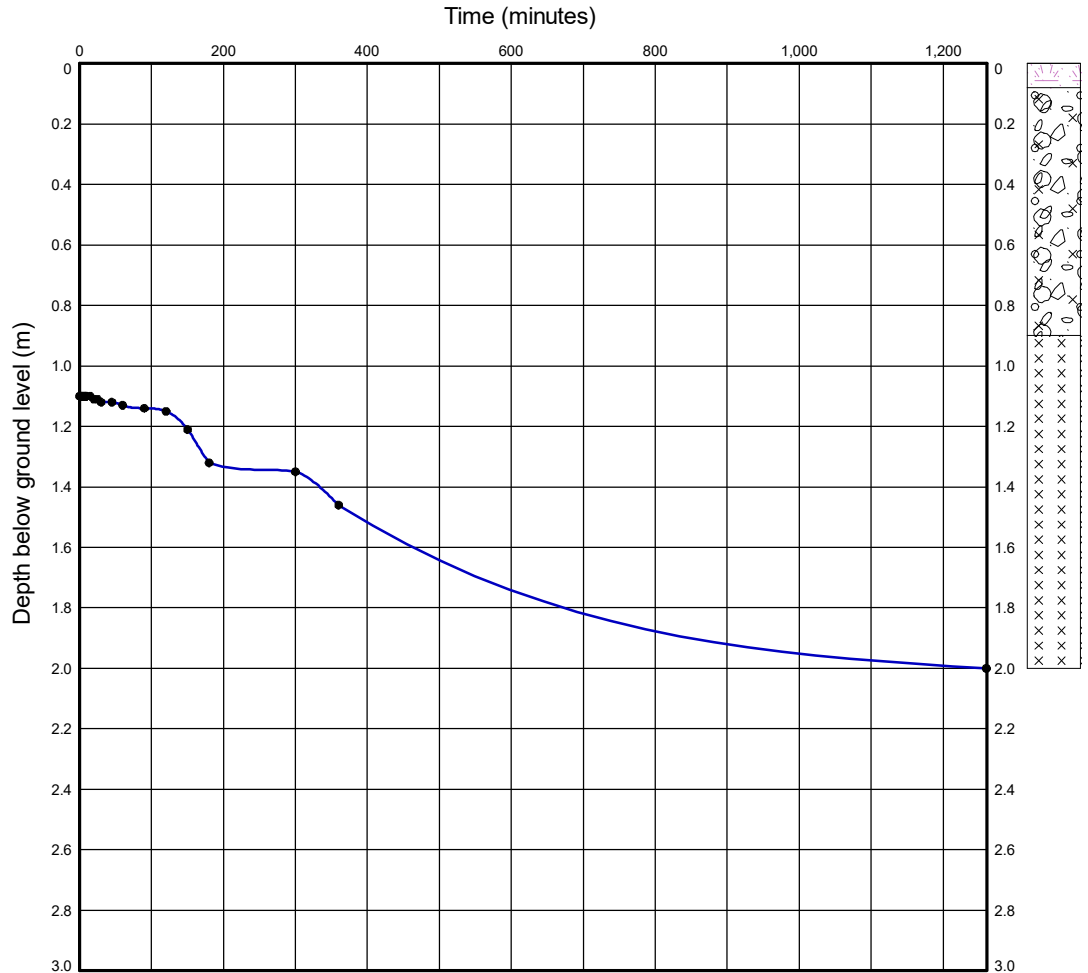
Field Observations from soakaway trial pit

Time (Minutes)	Depth of water from ground level (m)
0.0	1.1
1.0	1.1
2.0	1.1
3.0	1.1
4.0	1.1
5.0	1.1
6.0	1.1
7.0	1.1
8.0	1.1
9.0	1.1
10.0	1.1
15.0	1.1
20.0	1.11
25.0	1.11
30.0	1.12
45.0	1.12
60.0	1.13
90.0	1.14
120.0	1.15
150.0	1.21
180.0	1.32
300.0	1.35
360.0	1.46
1260.0	2

Soakaway test for soil infiltration rate
design method based on BRE Digest 365

The tests certificates for the Soakaway Tests can be found in Appendix IV with Table 4 outlining the tests undertaken.

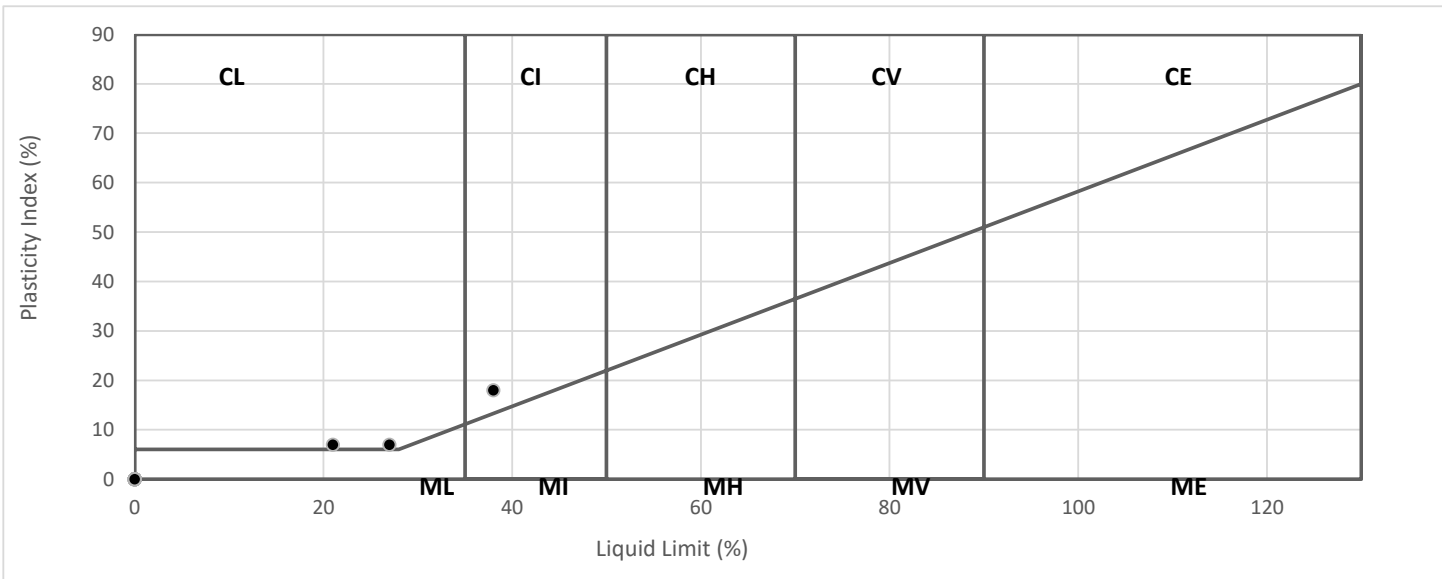
PLASTICITY CHART FOR CASAGRANDE CLASSIFICATION
 BS 5930:2015+A1:2020

**NATURAL MOISTURE, LIQUID LIMIT, PLASTIC LIMIT AND
PLASTICITY INDEX
(BS 1377:1990 - Part 2 : 4.3 & 5.3)**

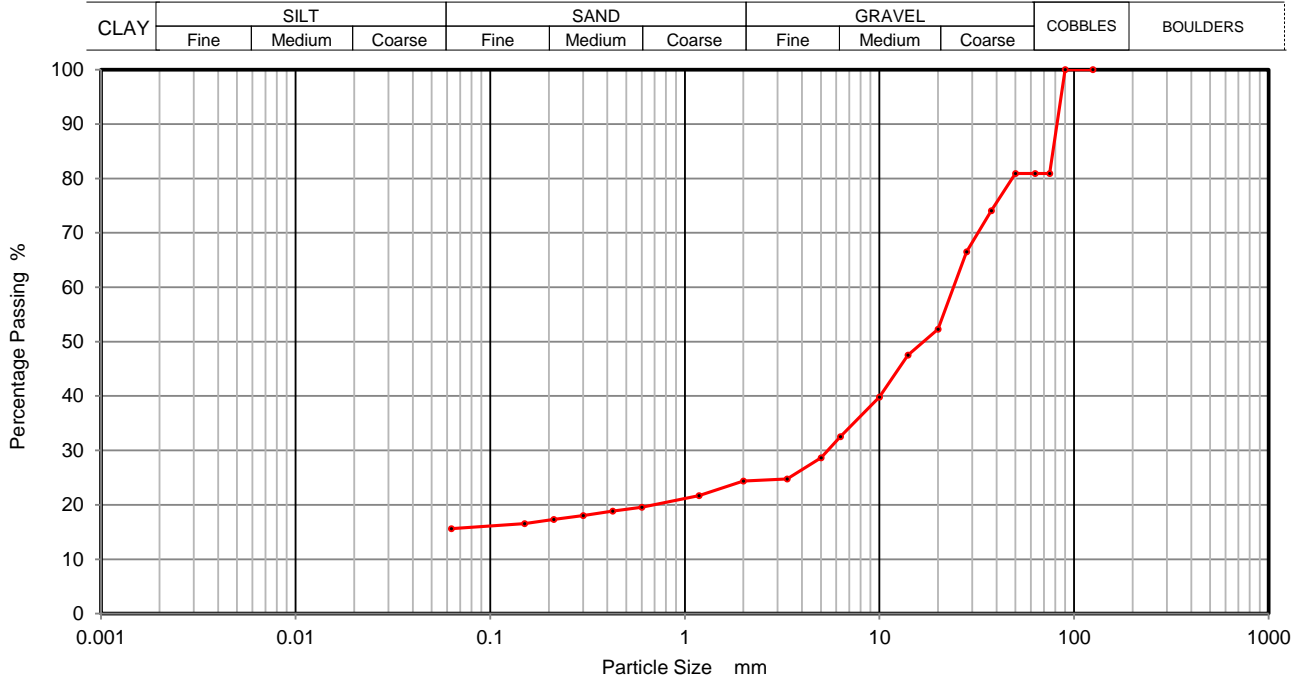
Sieving		Sedimentation	
Particle Size mm	% Passing	Particle Size mm	% Passing
125	100		
90	100		
75	81		
63	81		
50	81		
37.5	74		
28	67		
20	52		
14	48		
10	40		
6.3	33		
5	29		
3.35	25		
2	24		
1.18	22		
0.6	20		
0.425	19		
0.3	18		
0.212	17		
0.15	17		
0.063	16

Sample Proportions	% dry mass
Cobbles	19
Gravel	57
Sand	8
Silt and Clay	16

Made Ground		Range	Average	No. Tests
Particle Size Distribution	Cobbles (%)	19	19	1
	Gravel (%)	57	57	
	Sand (%)	8	8	
	Silt & Clay	16	16	
Water Soluble Sulphate as SO ₄	mg/l	<10	<10	7
pH	NA	6.8-8.2	7.7	7
SPT 'N' Value		5	5	1
Head Deposits		Range	Average	No. Tests
Moisture Content	(%)	8.-18	12	3
Atterberg Limits	Liquid Limit (%)	21-38	29	3
	Plastic Limit (%)	14-20	18	
	Plasticity Index (%)	7-18	11	
Passing 0.425mm	(%)	35-85	54	3
Particle Size Distribution	Cobbles (%)	0	0	2
	Gravel (%)	45-56	51	
	Sand (%)	15-20	18	
	Silt & Clay	29-35	32	
Water Soluble Sulphate as SO ₄	mg/l	<10	<10	3
pH	NA	6.8-8.8	7.8	3
SPT 'N' Value		7	7	1
Weathered / Weak Aberystwyth Grit Formation		Range	Average	No. Tests

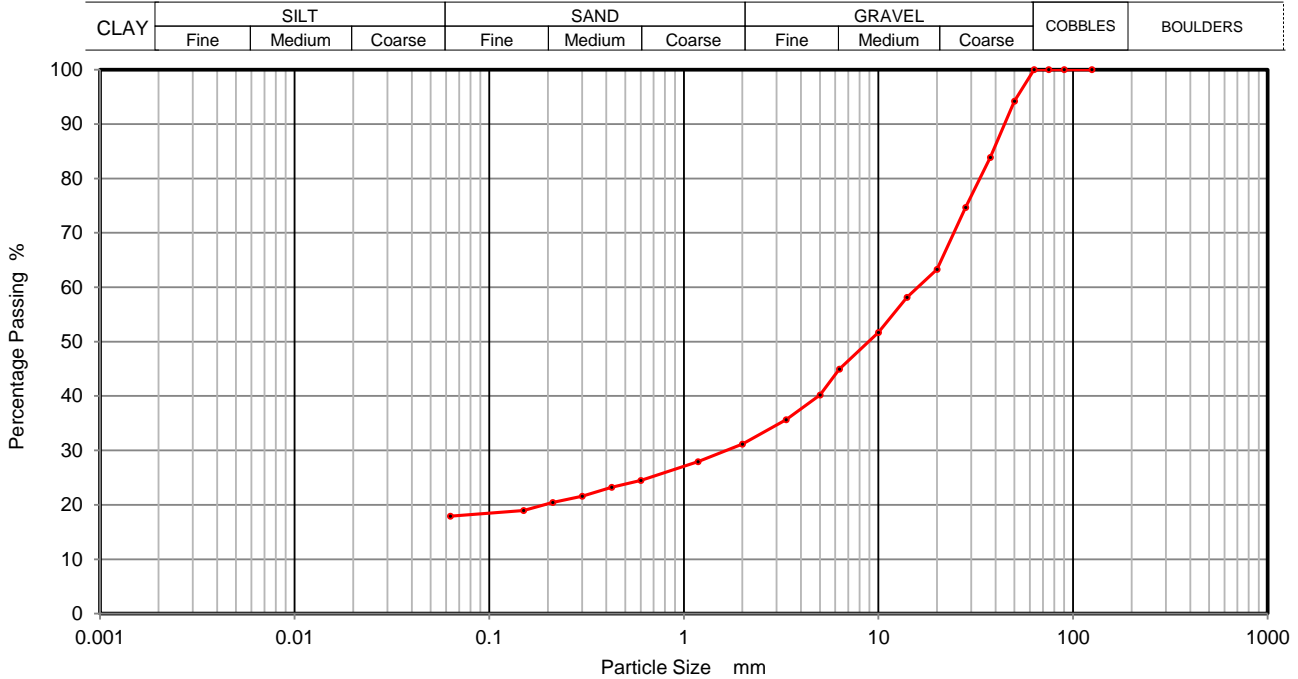
Sieving		Sedimentation	
Particle Size mm	% Passing	Particle Size mm	% Passing
125	100		
90	100		
75	100		
63	100		
50	94		
37.5	84		
28	75		
20	63		
14	58		
10	52		
6.3	45		
5	40		
3.35	36		
2	31		
1.18	28		
0.6	24		
0.425	23		
0.3	22		
0.212	20		
0.15	19		
0.063	18

Sample Proportions	% dry mass
Cobbles	0
Gravel	69
Sand	13
Silt and Clay	18

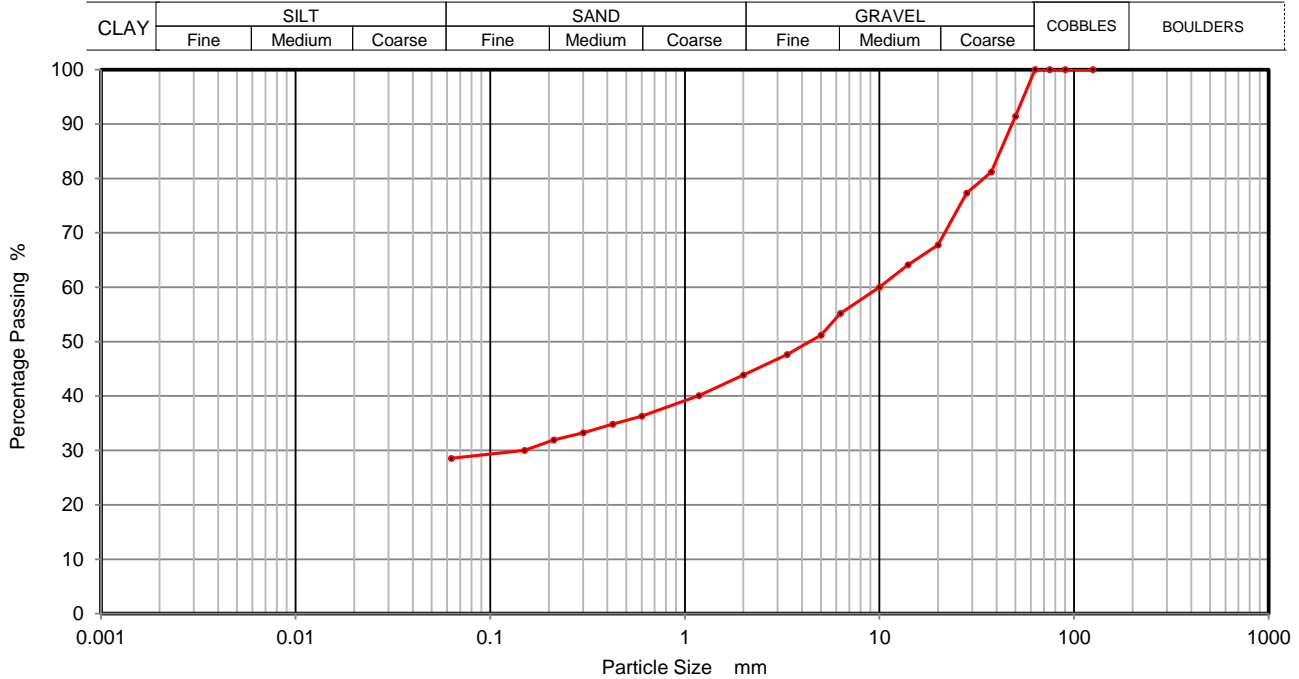
Sieving		Sedimentation	
Particle Size mm	% Passing	Particle Size mm	% Passing
125	100		
90	100		
75	100		
63	100		
50	91		
37.5	81		
28	77		
20	68		
14	64		
10	60		
6.3	55		
5	51		
3.35	48		
2	44		
1.18	40		
0.6	36		
0.425	35		
0.3	33		
0.212	32		
0.15	30		
0.063	29

Sample Proportions	% dry mass
Cobbles	0
Gravel	56
Sand	15
Silt and Clay	29

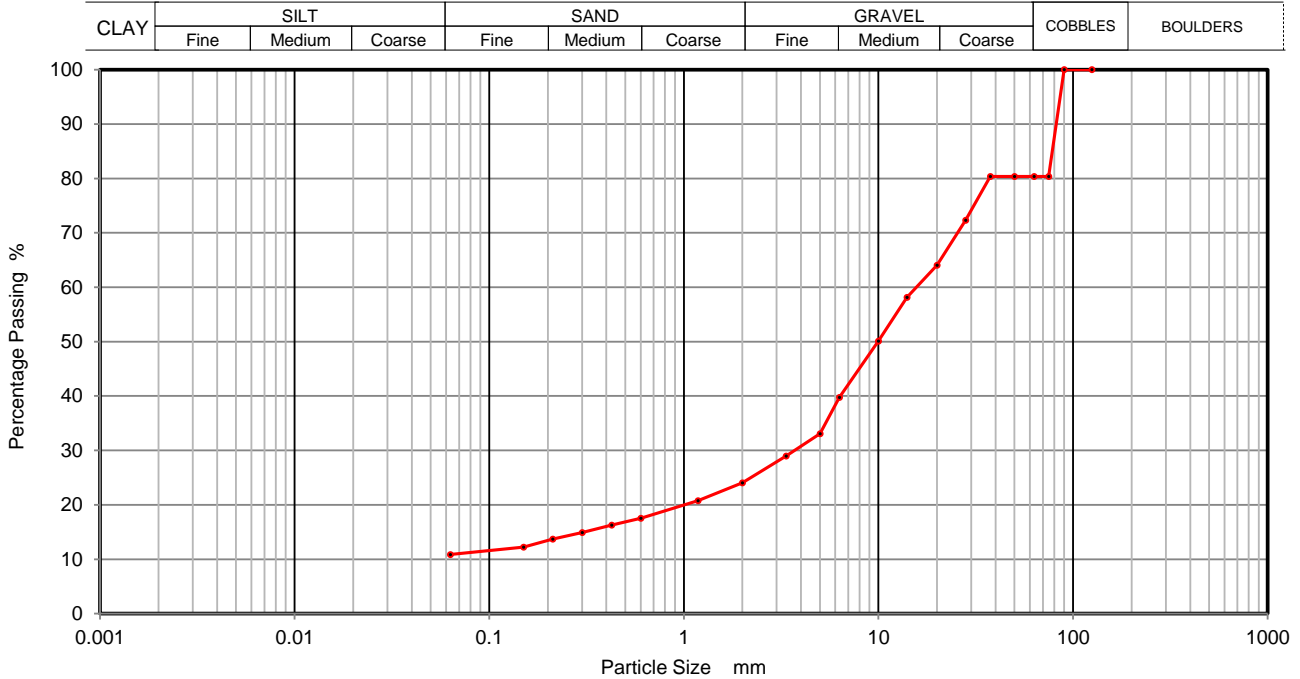
Sieving		Sedimentation	
Particle Size mm	% Passing	Particle Size mm	% Passing
125	100		
90	100		
75	80		
63	80		
50	80		
37.5	80		
28	72		
20	64		
14	58		
10	50		
6.3	40		
5	33		
3.35	29		
2	24		
1.18	21		
0.6	18		
0.425	16		
0.3	15		
0.212	14		
0.15	12		
0.063	11

Sample Proportions	% dry mass
Cobbles	20
Gravel	56
Sand	13
Silt and Clay	11

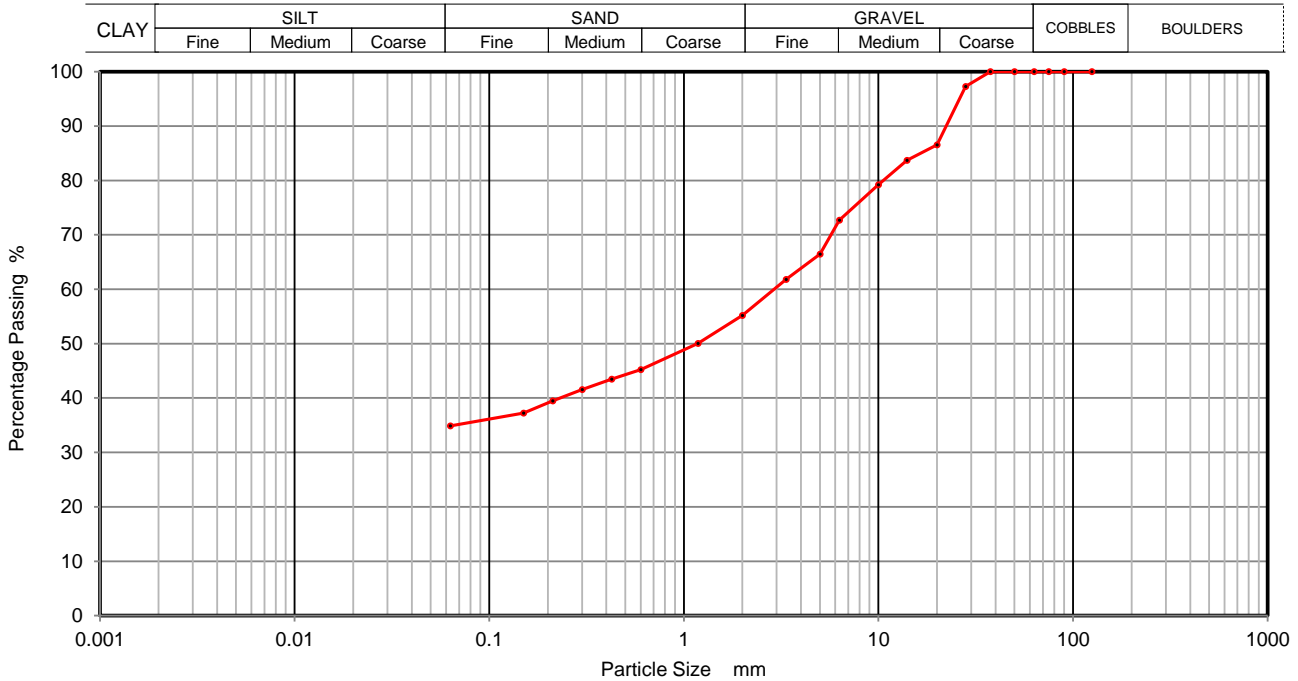
Sieving		Sedimentation	
Particle Size mm	% Passing	Particle Size mm	% Passing
125	100		
90	100		
75	100		
63	100		
50	100		
37.5	100		
28	97		
20	87		
14	84		
10	79		
6.3	73		
5	66		
3.35	62		
2	55		
1.18	50		
0.6	45		
0.425	43		
0.3	42		
0.212	39		
0.15	37		
0.063	35

Sample Proportions	% dry mass
Cobbles	0
Gravel	45
Sand	20
Silt and Clay	35

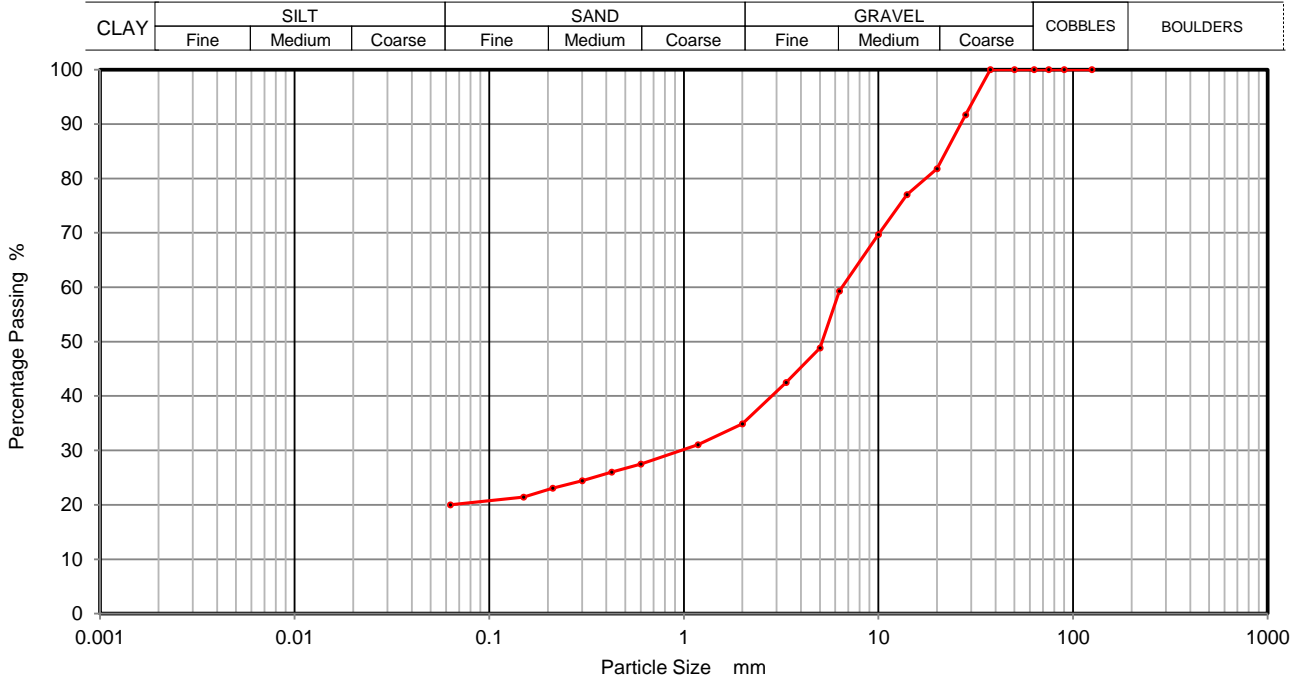
Sieving		Sedimentation	
Particle Size mm	% Passing	Particle Size mm	% Passing
125	100		
90	100		
75	100		
63	100		
50	100		
37.5	100		
28	92		
20	82		
14	77		
10	70		
6.3	59		
5	49		
3.35	42		
2	35		
1.18	31		
0.6	27		
0.425	26		
0.3	24		
0.212	23		
0.15	21		
0.063	20

Sample Proportions	% dry mass
Cobbles	0
Gravel	65
Sand	15
Silt and Clay	20
