Chandler KBS

Elan Valley Lakes

Preliminary Ecological Appraisal Report

Date of issue: September 2024

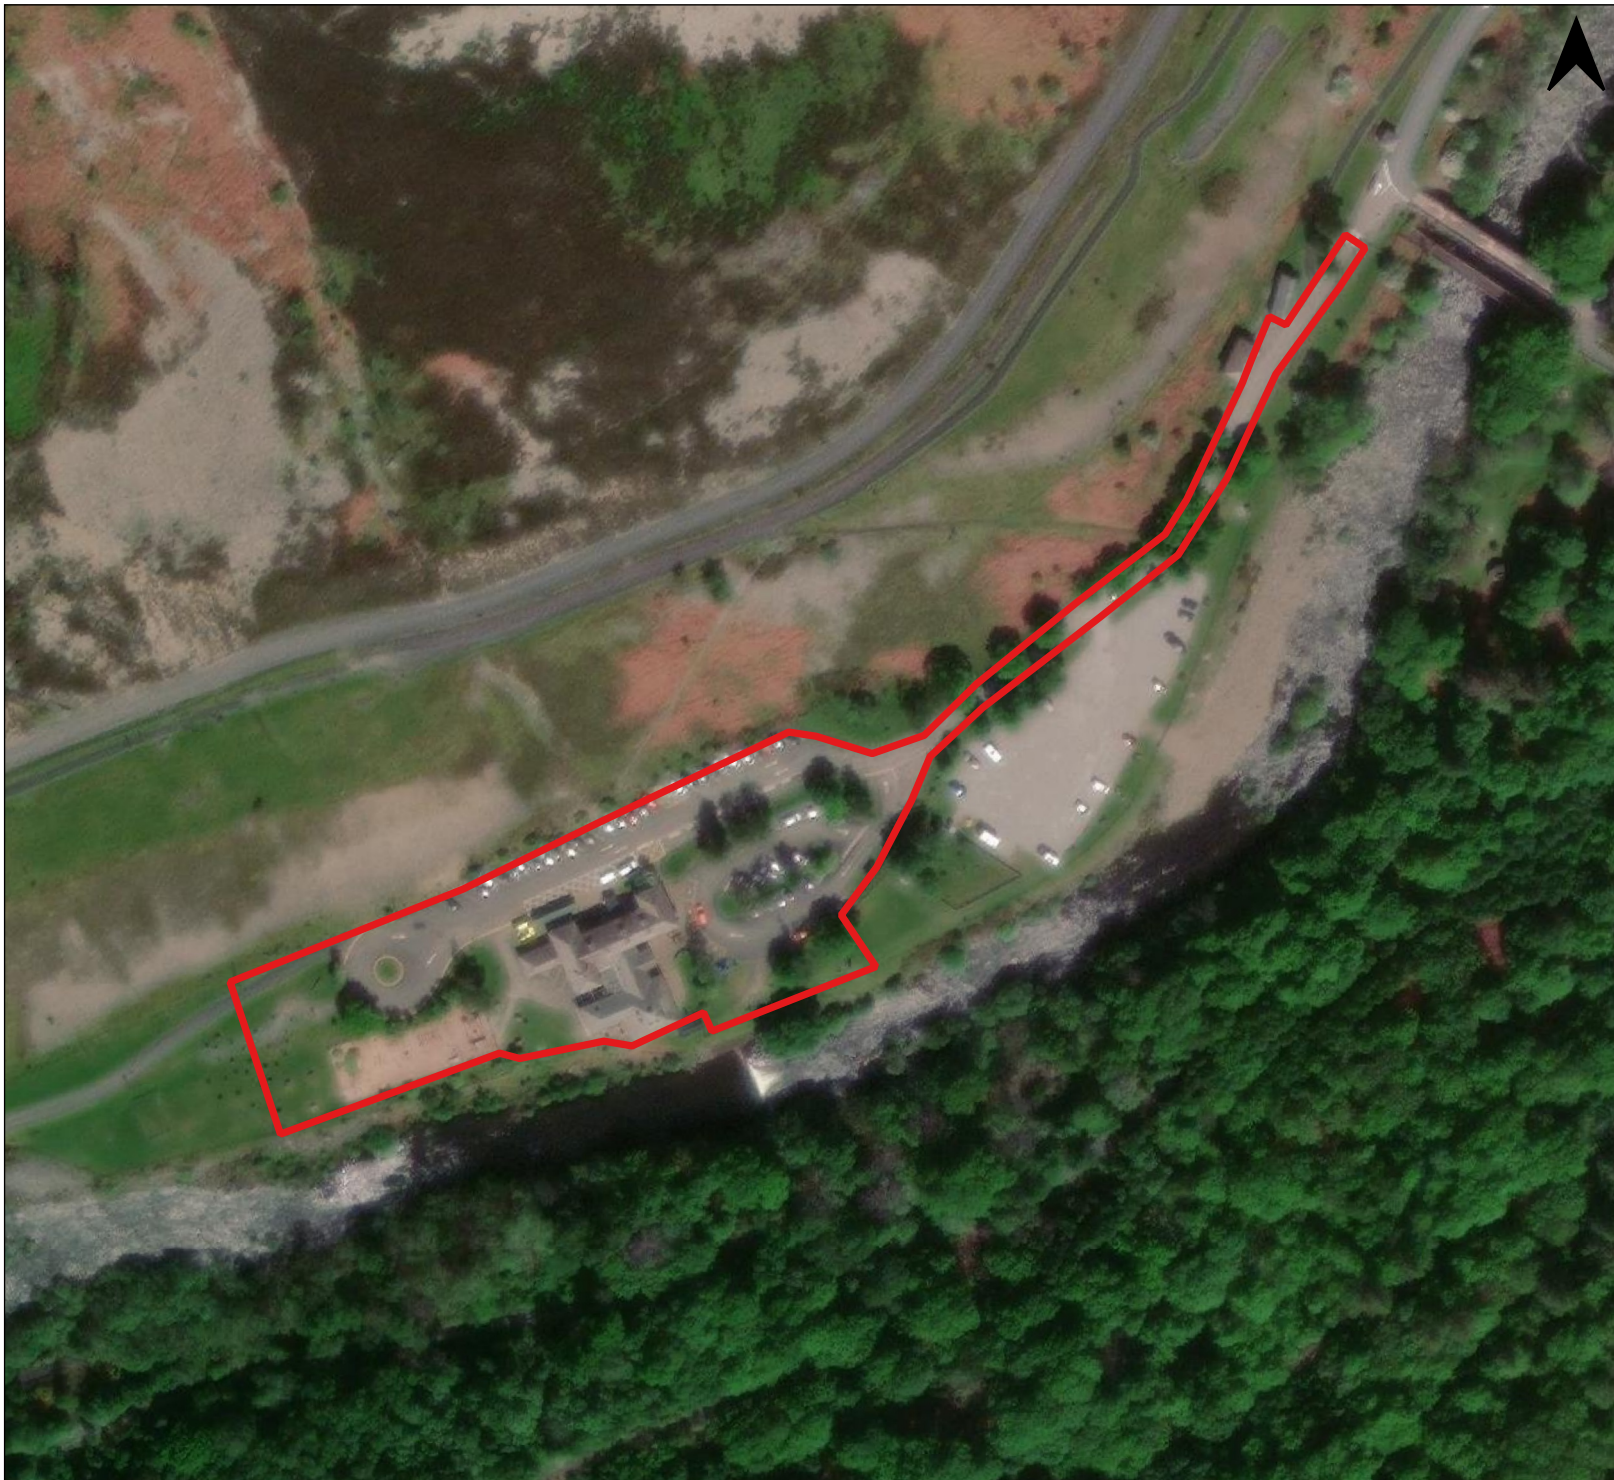
Figure 2 – UK Habitat Classification Plan

The UKHab survey involved undertaking a detailed walkover of the Site marked out by the survey boundary detailed in Section 1.4 and shown in Figure 1, Appendix A. The aim of UKHab is to provide a rapid system for recording and classifying habitats. The system comprises a principal hierarchy (the Primary Habitats, which include ecosystems, broad habitats, priority habitats and Annex 1 habitats) and non-hierarchical Secondary Codes. All habitats present on-site were recorded on a UKHab map (Figure 2, Appendix A).

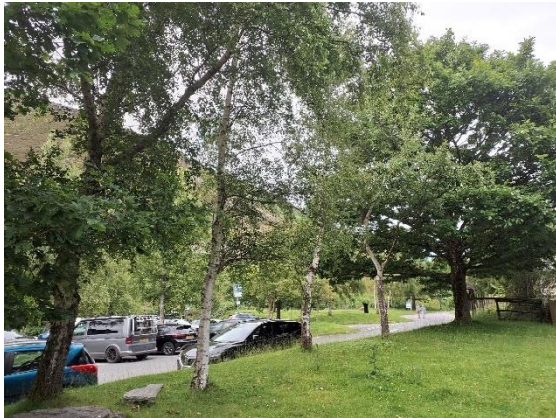
Phase 1 Habitat Name and Code	Description and Species Present	Ecological Importance and Potential for Adverse Effects	Condition Assessment Score
w1g - Broadleaved woodland	Small patches of broadleaved and mixed woodland are found throughout the Site, consisting of red oak (<i>Quercus rubra</i>), rowan (<i>Sorbus aucuparia</i>) and silver birch (<i>Betula pendula</i>). The ground cover is grazed grassland, which adjoins the woodland (Photograph 1).	The woodland found on Site is present in small, isolated stands within the car park and landscaping. A small number of trees are likely to be removed to facilitate works and improve access. There is the potential for damage to tree roots if excavation is required to extend the car park, in which case an arborist should be consulted.	Poor
h3h - Dense mixed scrub	A small area of dense, mixed scrub is present located north of the visitor centre building, consisting of hawthorn (<i>Crataegus monogyna</i>), privet (<i>Ligustrum ovalifolium</i>) and honeysuckle (<i>Lonicera periclymenum</i>).	The scrub is small and isolated nature which limits its ecological importance. However it has the potential to support breeding birds.	Poor

Photograph 1: w1g - Broadleaved woodland

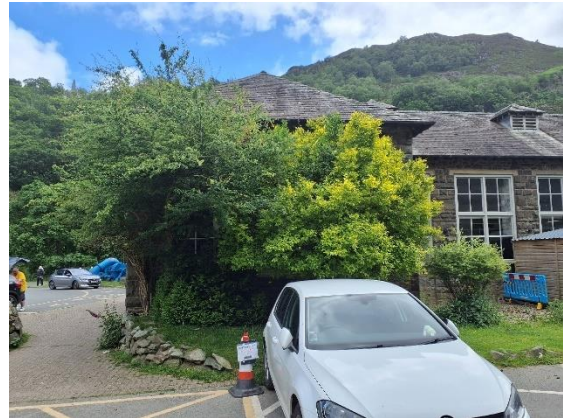
Photograph 2: h3h - Dense mixed scrub

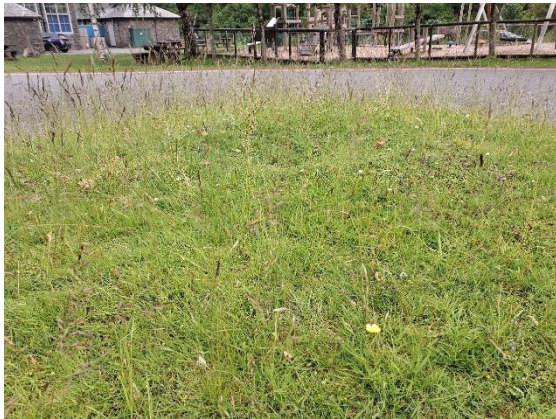
g3c – Other neutral grassland	Small patches of other neutral grassland are found throughout the Site, including an area of Lolium-Cynosurus grassland to the south of the Site. Species present include daisy (<i>Bellis perennis</i>), white clover (<i>Trifolium repens</i>), meadow buttercup (<i>Ranunculus acris</i>), crested dog's-tail (<i>Cynosurus cristatus</i>), creeping thistle (<i>Cirsium arvense</i>), and sharp-flowered rush.	This species-rich grassland has ecological importance for pollinators, however it is not expected to be impacted by the works.	Poor - Moderate

Photograph 3: g3c – Other neutral grassland

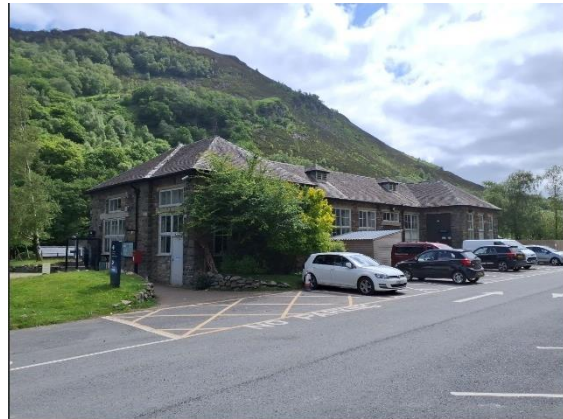
The original building has gaps around the wall tops with access points for bats and roof nesting birds. There are a small number of holes in the walls where services may have previously entered the building that may be suitable for roosting bats. The roof on the west elevation has some raised or missing slates that may provide access points / roosting opportunities for bats. **There is high potential to support roosting bats in the original building.**

Photograph 4: Early 20th century workshop

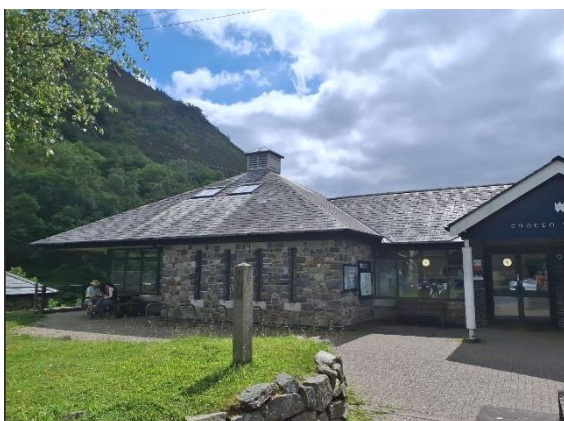
The modern extension has well sealed soffits and the roof is in good condition. The only potential roost feature is the cupola vent. **There is low potential for roosting bats in the modern extension.**

Photograph 5: 1980's extension

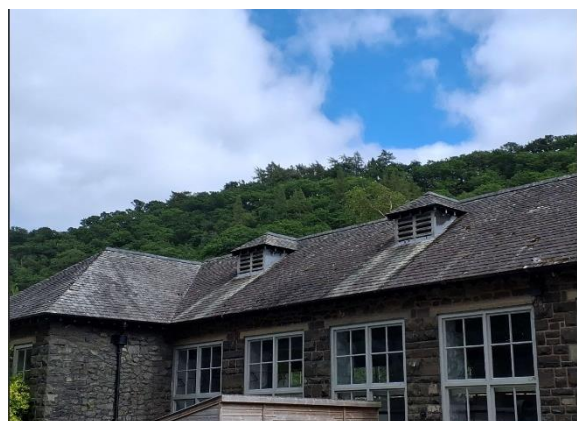
Photograph 6: Ventilation cupola.
