Appendix A

Intégral Géotechnique

Phase 1, Former Tudor Inn, Beacons View, Cimla, Neath, SA11 3SB

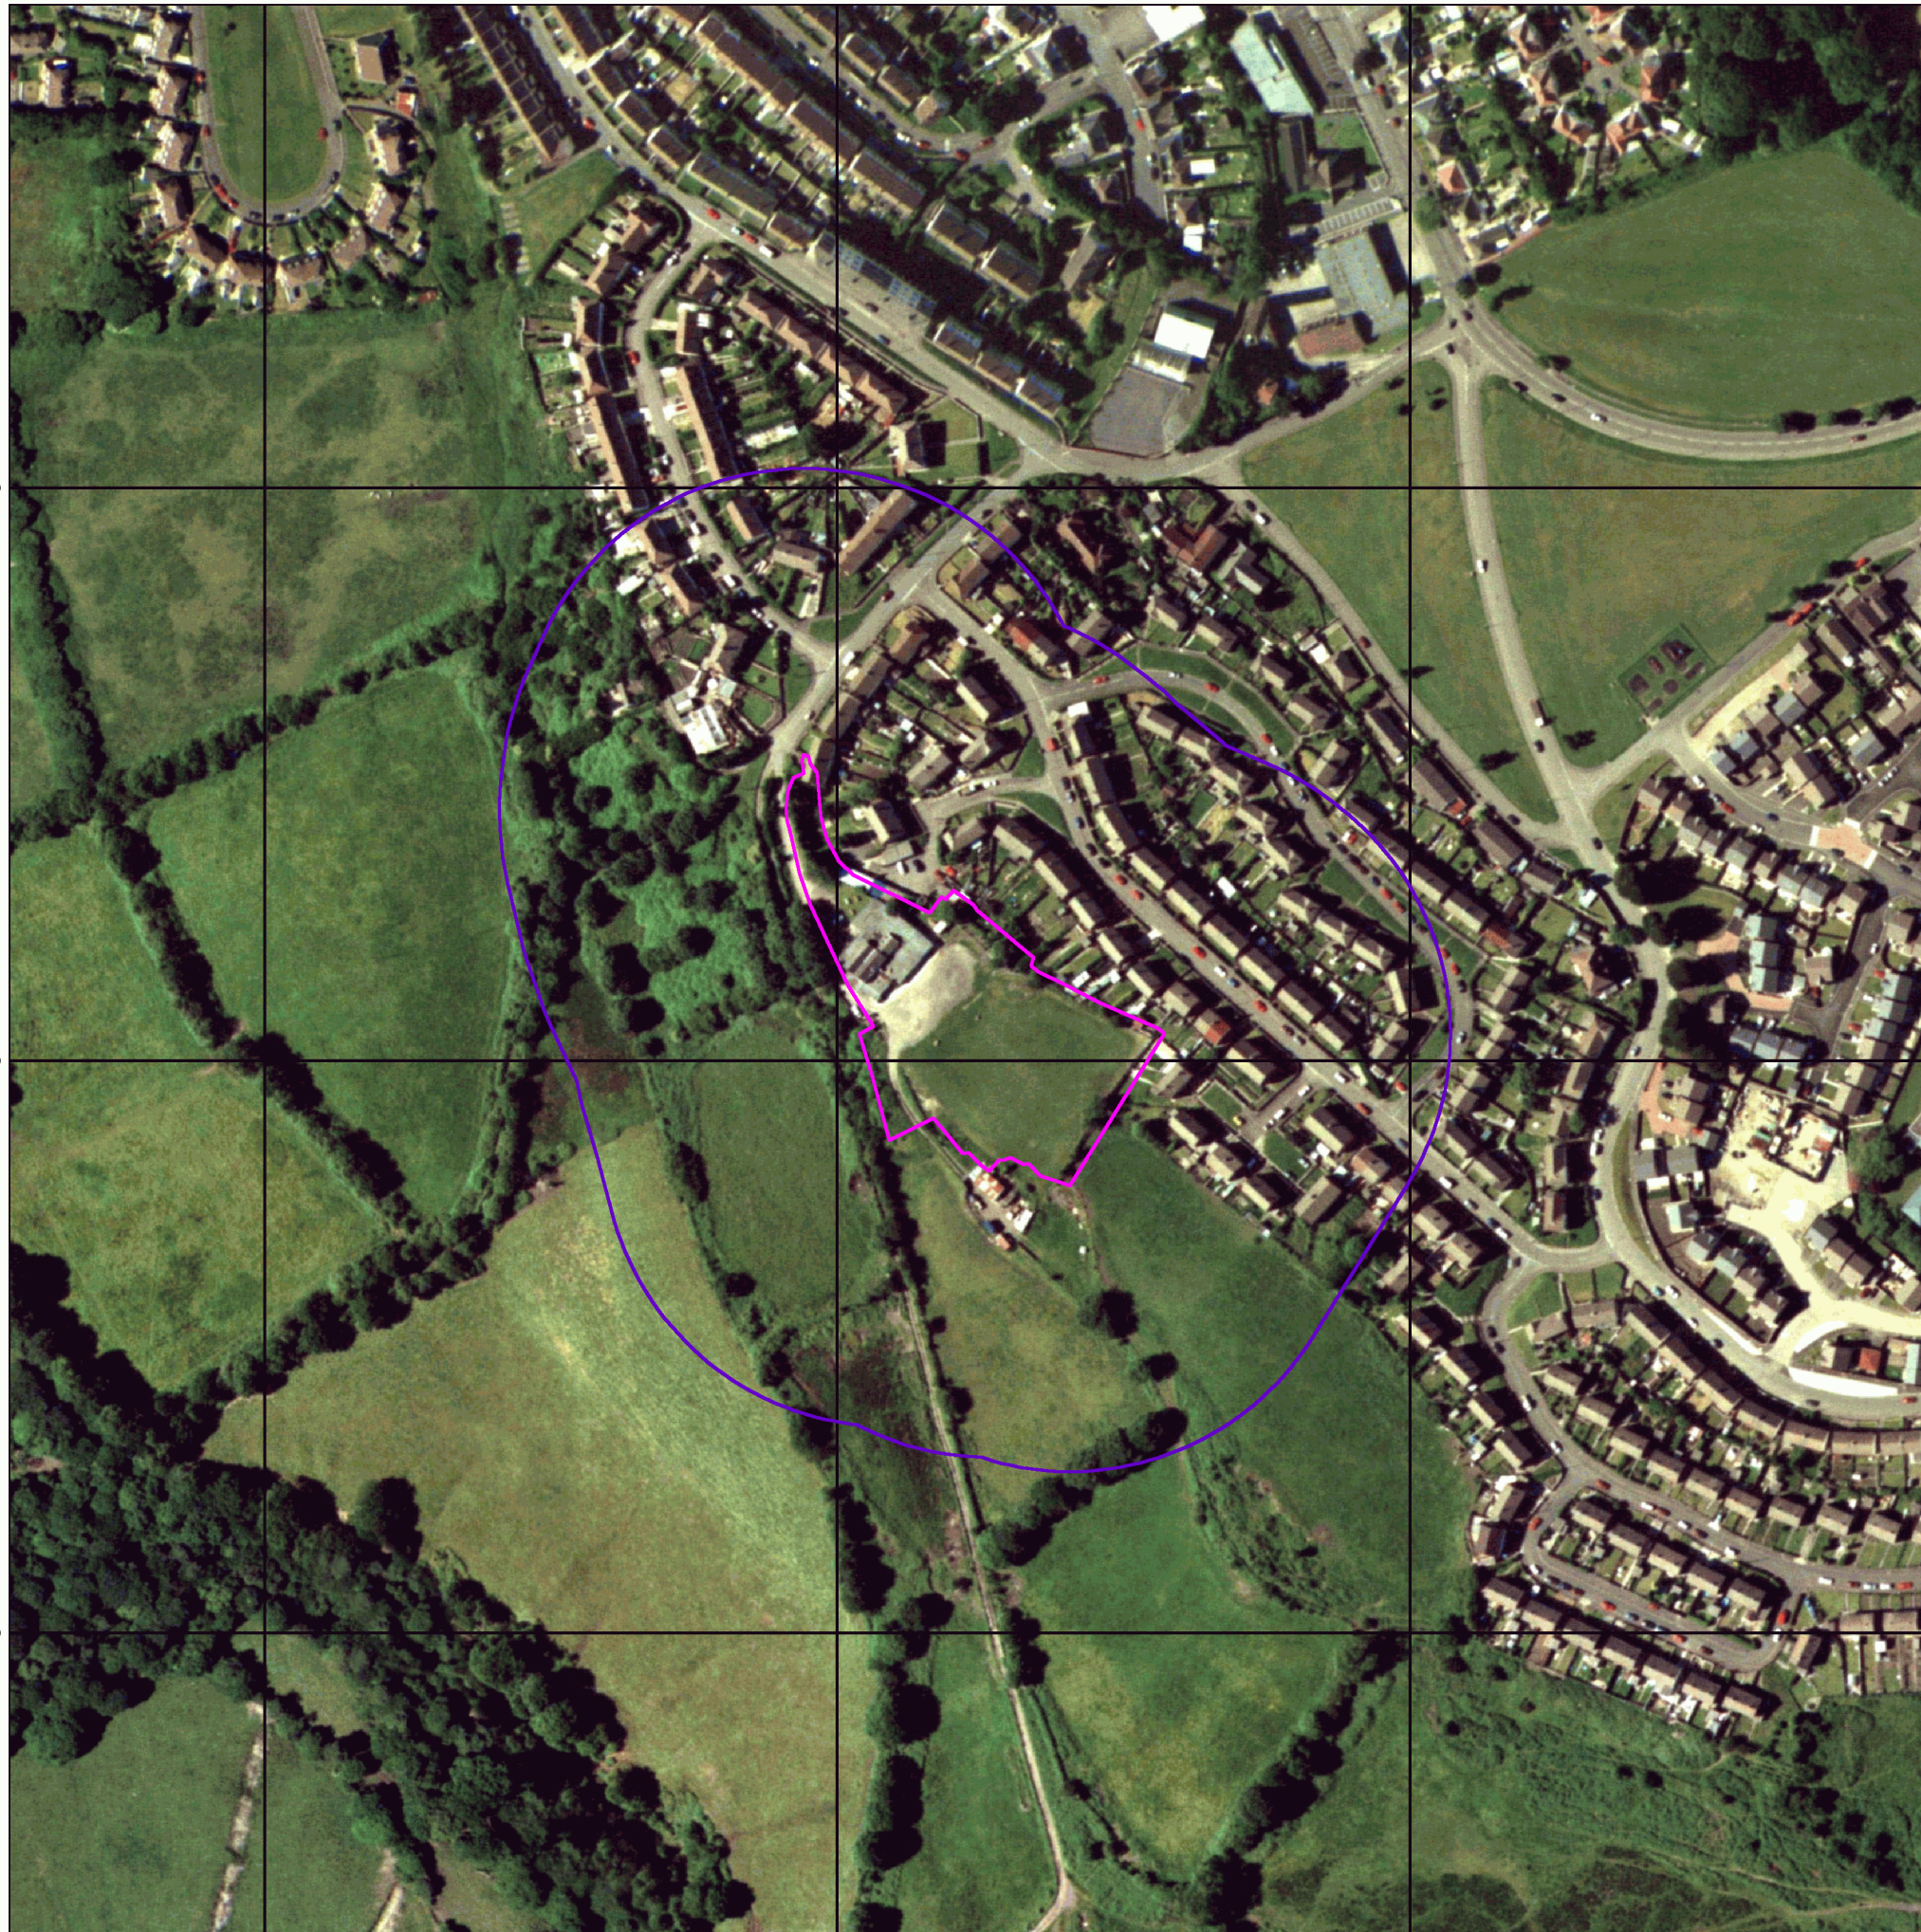
Historical Aerial Photography - Segment A13

This aerial photography was produced by Getmapping, these vertical aerial photographs provide a seamless, full colour survey of the whole of Great Britain
