Technical Note

Project title	Elan Valley Visitor Centre
Job number	303909
File reference	4-20
cc	Dŵr Cymru Welsh Water
Prepared by	Richard Cottrell
Date	9 August 2024
Subject	Geotechnical Desk Study & Contaminated Land Preliminary Risk Assessment

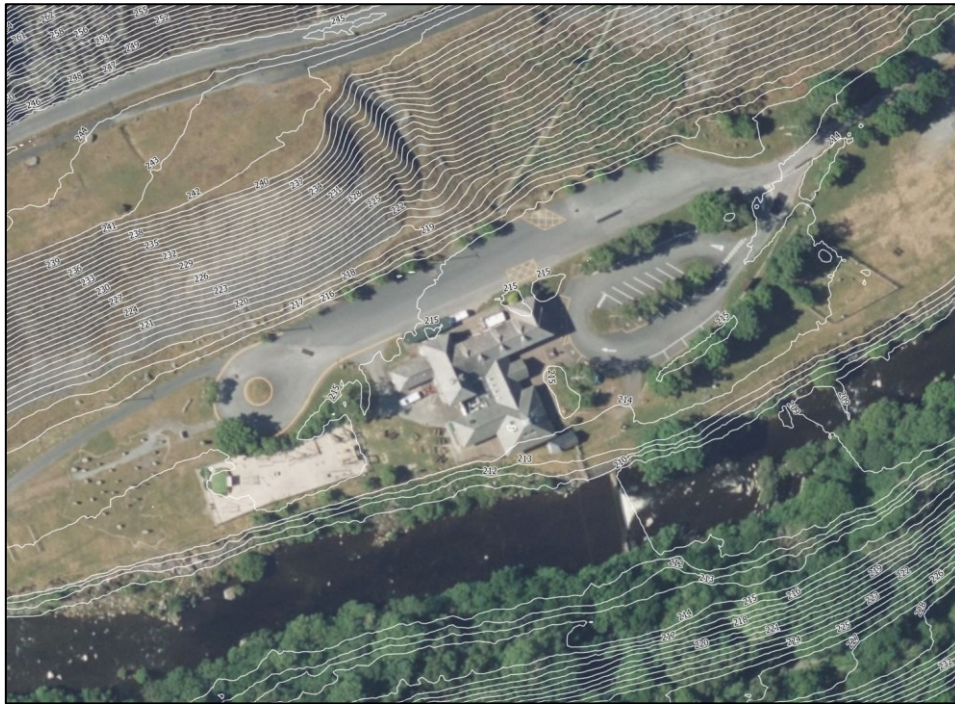
Figure 1: Site layout.

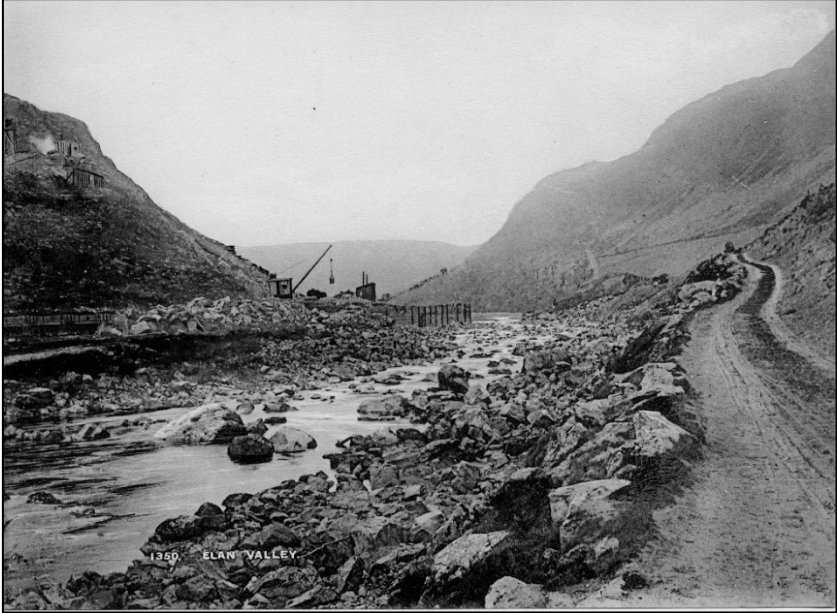
<p data-bbox="528 1131 1426 1187">Photograph 1: Photograph showing early stage of the construction of Caban Coch Dam. Historical ground profile shown in foreground [2].</p>
1902-1904	Historical Photographs [2]

The site’s history is dominated by its role during the construction of Caban Coch Dam. The former sloped, rough riverbank (shown in Photograph 1 appears to have been reclaimed to form a plateau to facilitate buildings for the dam’s construction (see Photograph 2), and subsequent redevelopment in to a visitor centre. A summary of the site’s history is presented in Table 1.

No natural Superficial Deposits are mapped under the site, with the nearest natural deposits mapped ~180m downstream (east) comprising Alluvium (clay, silt, sand and gravel). Photograph 1 shows the natural ground profile before the riverbank was reclaimed for the construction of Caban Coch Dam. The ground surface appears to comprise large boulders likely originating from weathered Caban Conglomerate rock. The plateau of land that contains the site is there for expected to comprise predominantly Made Ground. The source of this material to form the plateau is unknown. The material is also the main potential source of contamination for the site as the material may contain waste materials associated with the dam's construction.

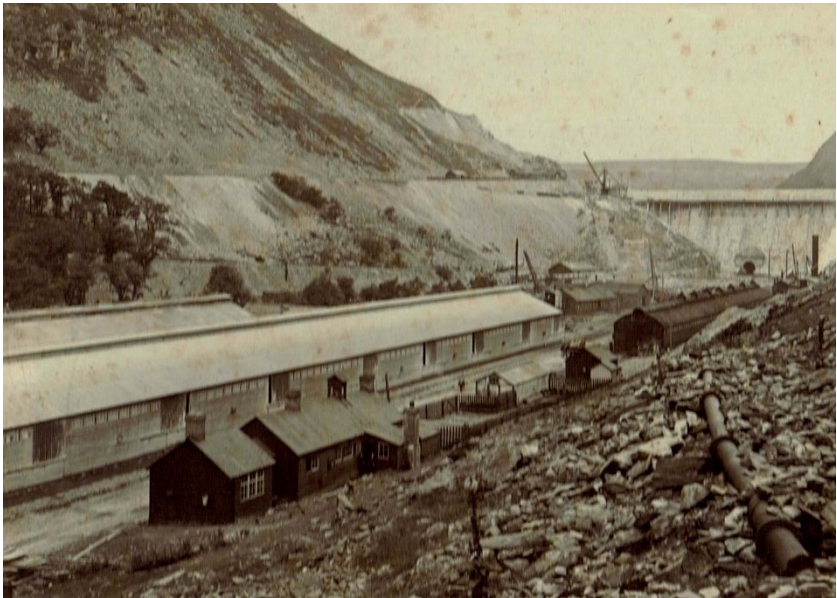
<p data-bbox="691 1832 1265 1861">Photograph 2: Auxiliary buildings at Caban Coch [2].</p>
1905	County Series OS Map (1:10,000 Scale, and 1:2,500 Scale)	Footpaths and bridges no longer shown. New suspension bridge annotated to the north-east. Caban Coch Dam annotated as “in course of construction”. Quarry annotated to the west. Current stockpile plateau shown to the north-west. “Tanks” annotated to the north of the site along the current alignment of the B4518. Buildings from Photograph 2 not shown on OS

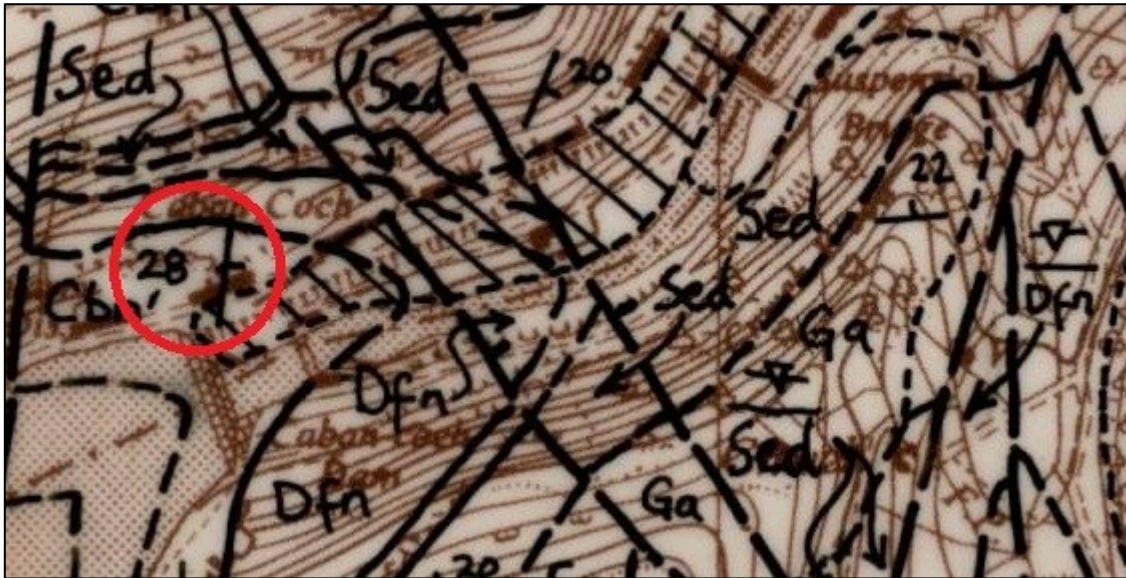
Figure 3: Extract from 1:10,000 scale geology map [5]. Narest recorded dip measurement circled in red.

The BGS published geology of the site shows the bedrock geology underlying the site to comprise the Caban Conglomerate Formation (see Figure 2). This comprises interbedded Mudstone and Sandstone [4]. Two faults are mapped bounding the site striking north-west to south-east with the nearest recorded dip measurement recorded ~350m west of the site showing a 28° dip to the east (see Figure 3) [5].
