HIRWAUN ROAD, PENYWAUN

DRAINAGE STRATEGY REPORT

Newydd Housing Association

Document ref no. 22135-R-601-DRAINAGE STRATEGY

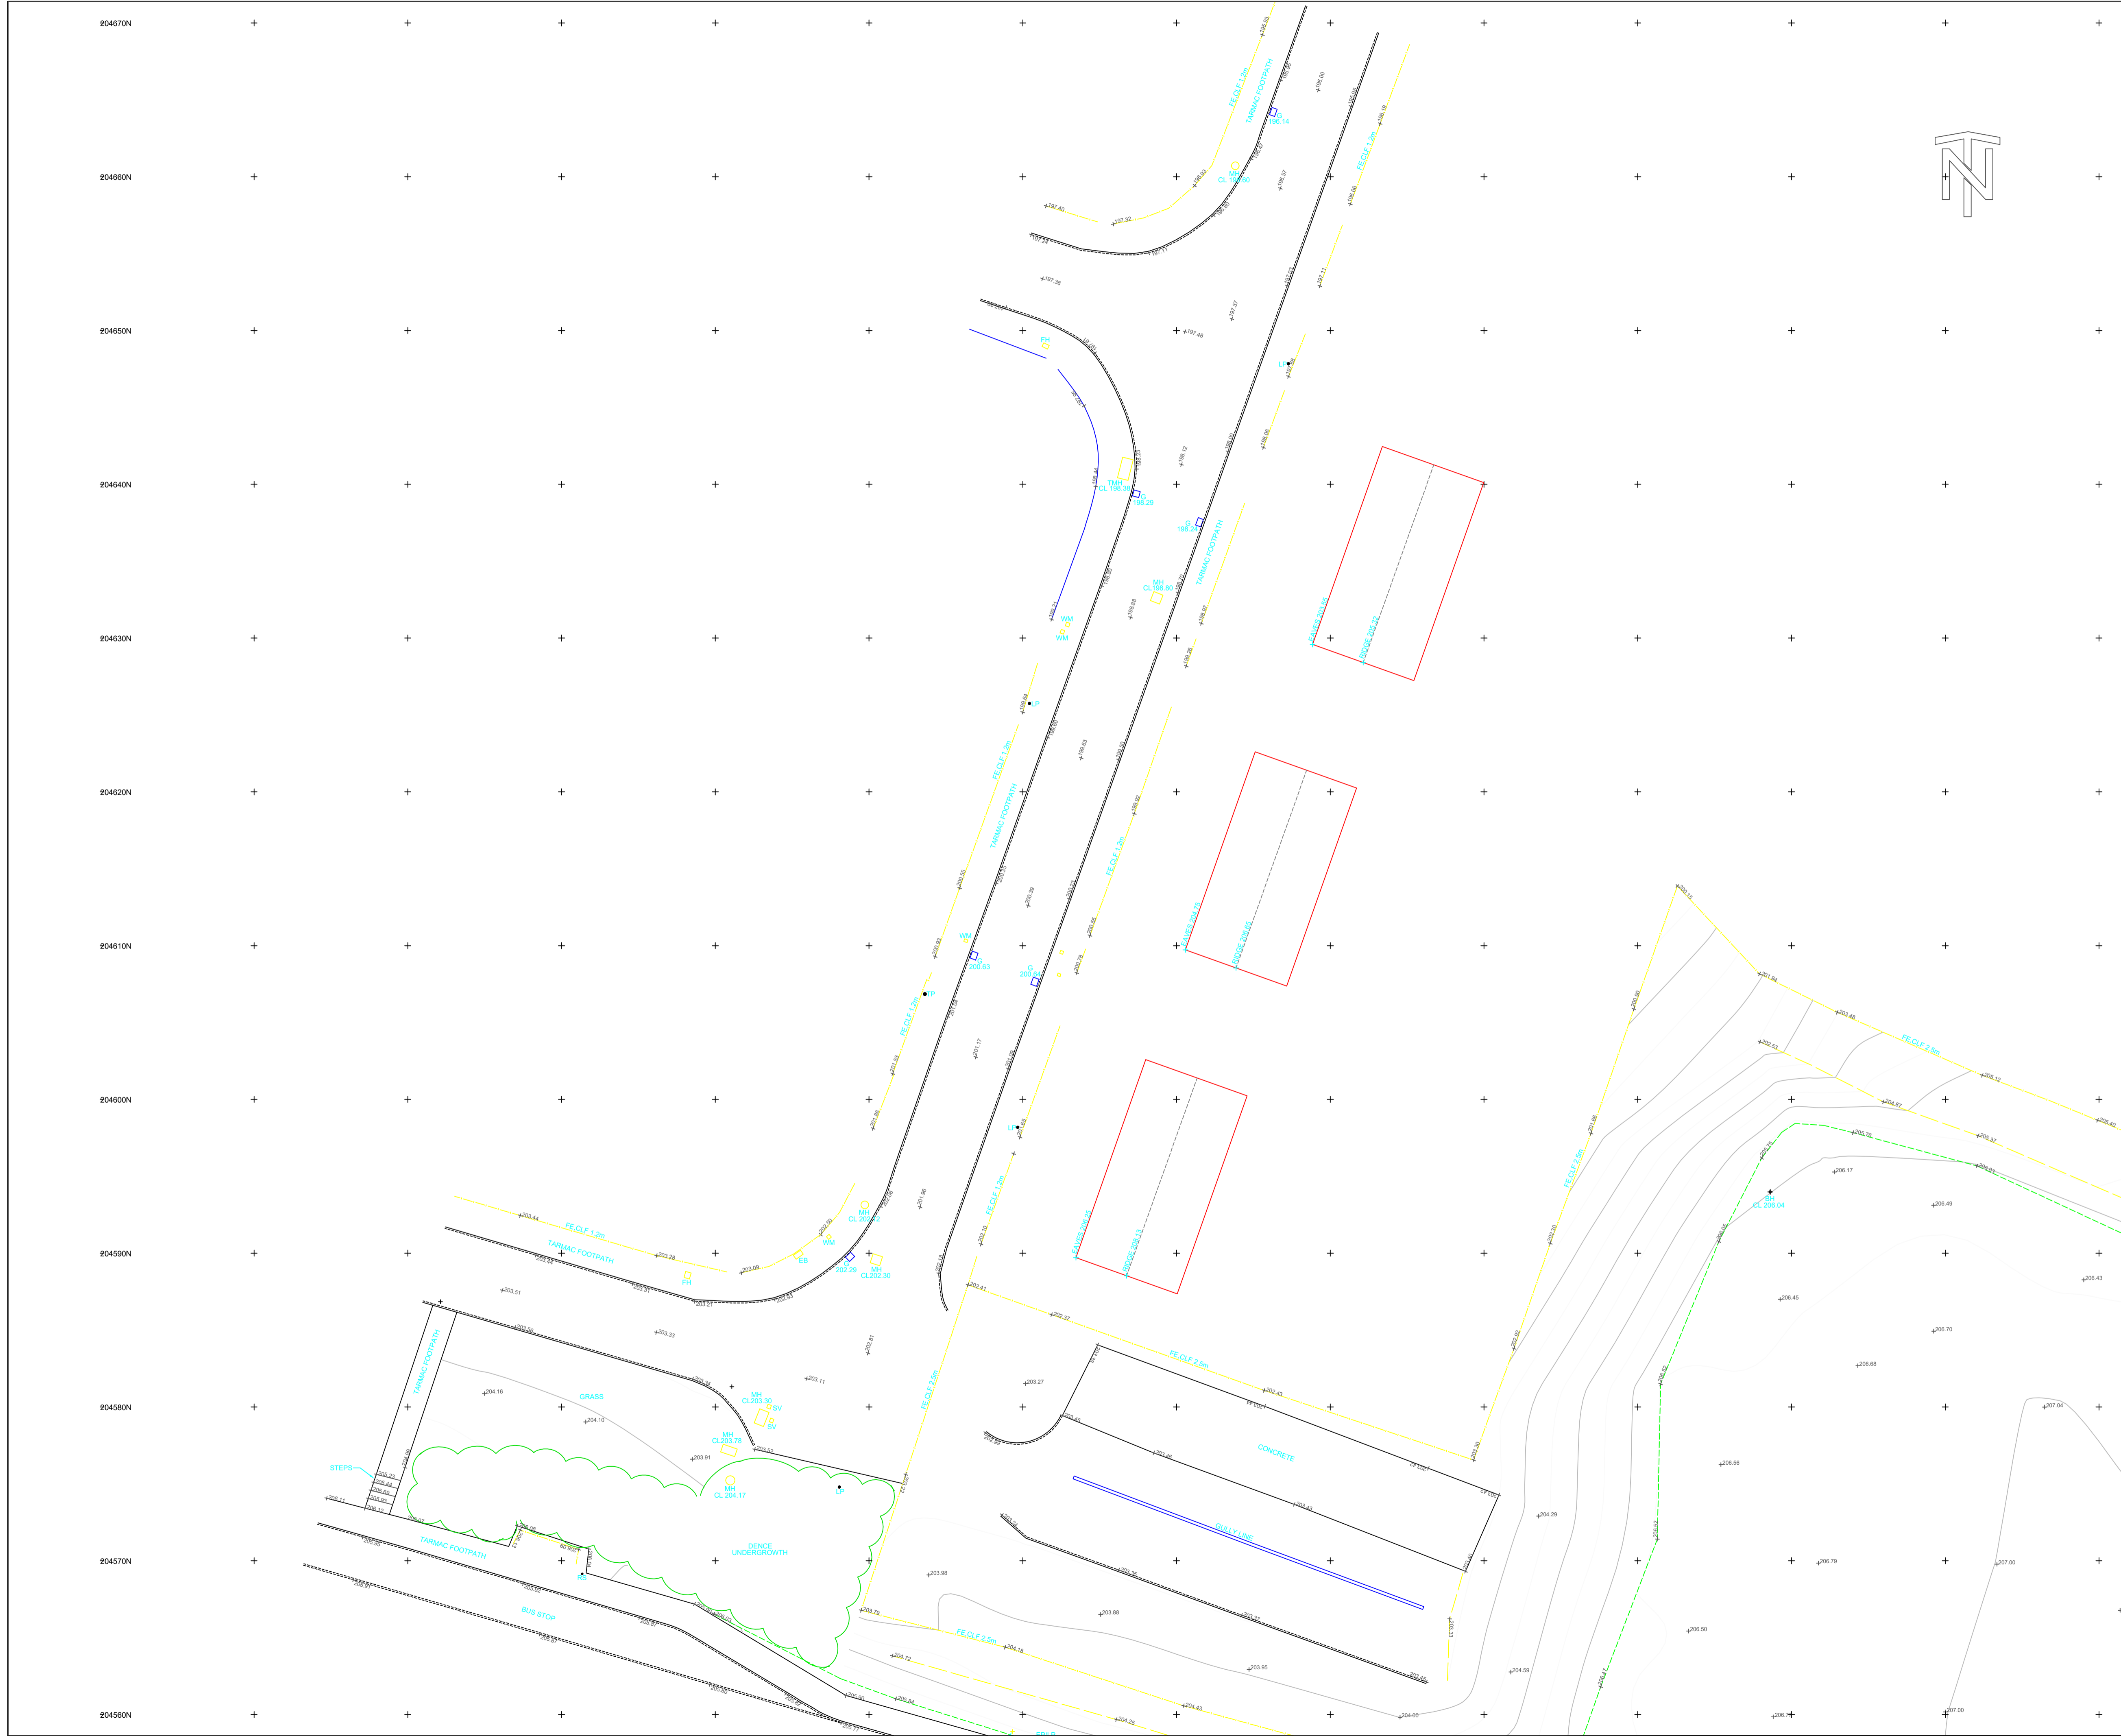
APPENDIX 1 – EXISTING SITE SURVEY

- 2.1 The site is located in the North of Hirwaun Road, Penywaun, nearest post code is CF44 9DE, site coordinates 297513, 204568.
- 2.2 The existing site topography (Appendix 1) falls in a western direction with an approximate level range of 207.10 – 203.79m which has been confirmed by means of a topographical survey undertaken by Usk Land Surveys. The majority of the site is currently open green space to the east with a concrete hardstanding located to the south west corner. The site boundaries are bounded to the south with the main carriageway, the north with greenfield / woodland, and an existing estate road and car park to the east and west. Nearest watercourses were identified by the ground investigation which noted the River Cynon located approximately 430m north of the site and a small in-land river running east 67m north of the site.

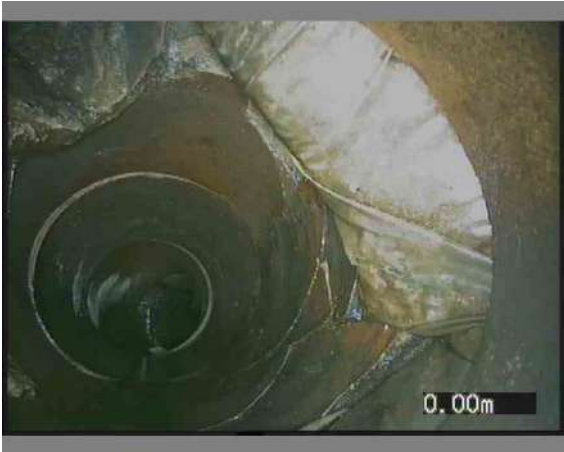
2-1-3A, 00:00:12, 0.20 m
Fracture, multiple at joint, from 7 to 5 o'clock

Scale:	1:50	Position [m]	Code	Observation	MPEG	Photo	Grade
		0.00	MH	Start node type, manhole, reference number : SMH2	00:00:00		
		0.00	WL	Water level, 05% of the vertical dimension	00:00:07		
		0.20	FMJ	Fracture, multiple at joint, from 7 to 5 o'clock	00:00:12	2-1-3A	4
		0.20	H	Hole in drain/sewer, from 11 to 4 o'clock	00:00:22	2-1-4A	5
		0.20	CXI	Connection intruding, at 10 o'clock, diameter 150mm, intrusion 05%	00:00:39		5
		1.49	LR	Line deviates right	00:01:02		
		2.84	MHF	Finish node type, manhole reference number: SMH3	00:01:08

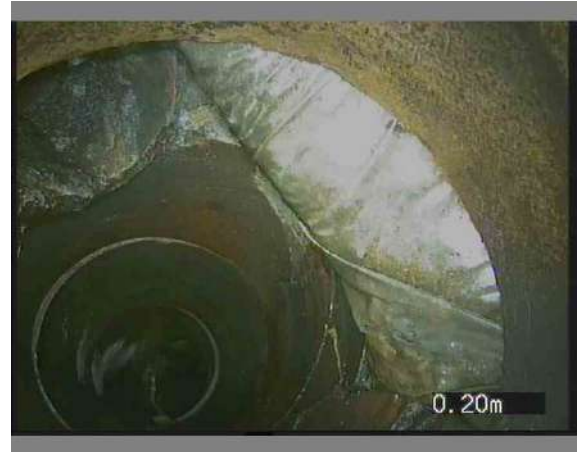
2-1-4A, 00:00:22, 0.20 m
Hole in drain/ sewer, from 11 to 4 o'clock

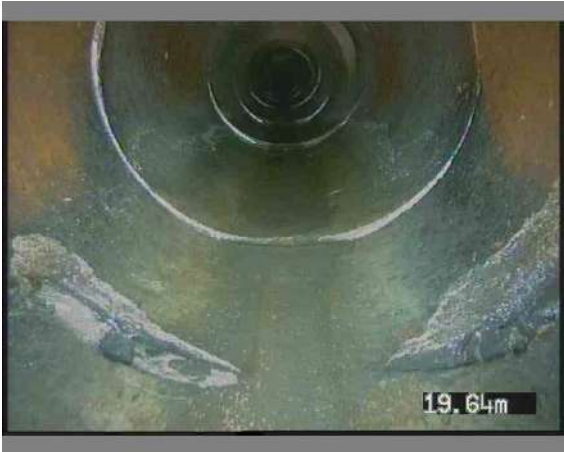
3-1-6A, 00:02:56, 19.64 m
 Hole in drain/sewer, from 7 to 8 o'clock

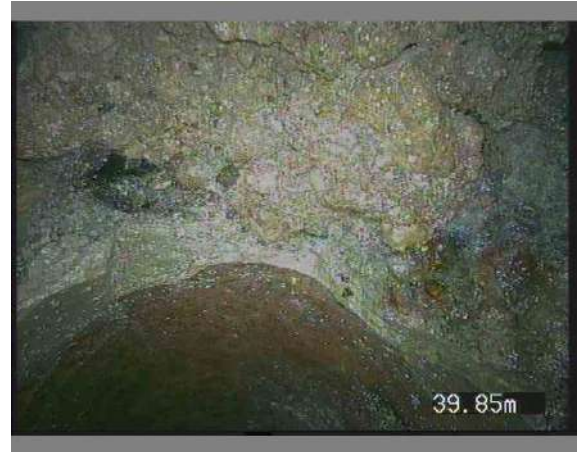
3-1-14A, 00:07:34, 39.85 m
 Hole in drain/sewer, from 9 to 3 o'clock

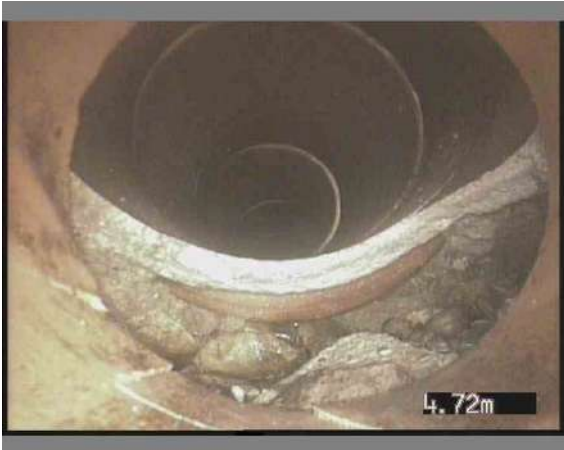
4-1-8A, 00:00:59, 4.72 m
Survey abandoned, UNABLE TO PASS

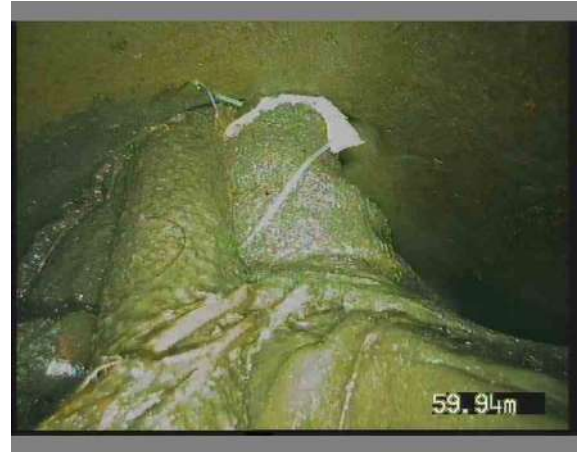
5-1-12A, 00:10:10, 59.94 m
Survey abandoned, NEEDS MORE CLEANING

</div>									0.00	MH	Start node type, manhole, reference number : SMH5	00:00:00					0.00	WL	Water level, 0% of the vertical dimension	00:00:10					0.00	S01 DEEJ	Attached deposits, encrustation at joint, from 7 to 5 o'clock, 5% cross-sectional area loss, Start: PATCHY	00:02:29					16.24	JN	Junction, at 12 o'clock, diameter 375mm: CAPPED	00:02:03					26.46	JN	Junction, at 10 o'clock, diameter 150mm	00:03:04					29.71	JN	Junction, at 10 o'clock, diameter 150mm	00:03:38					29.84	SS	Surface damage, spalling, from 10 to 12 o'clock	00:04:07			2		39.96	JN	Junction, at 12 o'clock, diameter 375mm: CAPPED	00:05:18					58.72	JN	Junction, at 10 o'clock, diameter 150mm	00:08:15					59.94	F01 DEEJ	Attached deposits, encrustation at joint, from 7 to 5 o'clock, 5% cross-sectional area loss, End: PATCHY	00:09:52			2		59.94	JN	Junction at 10 o'clock, diameter: 150mm: STEEL ROD THROUGH GULLY HOLDING DEBRIS BACK	00:10:04		5-1-11A			59.94	SA	Survey abandoned: NEEDS MORE CLEANING	00:10:10		5-1-12A	
	0.00	MH	Start node type, manhole, reference number : SMH5	00:00:00																																																																																																			
	0.00	WL	Water level, 0% of the vertical dimension	00:00:10																																																																																																			
	0.00	S01 DEEJ	Attached deposits, encrustation at joint, from 7 to 5 o'clock, 5% cross-sectional area loss, Start: PATCHY	00:02:29																																																																																																			
	16.24	JN	Junction, at 12 o'clock, diameter 375mm: CAPPED	00:02:03																																																																																																			
	26.46	JN	Junction, at 10 o'clock, diameter 150mm	00:03:04																																																																																																			
	29.71	JN	Junction, at 10 o'clock, diameter 150mm	00:03:38																																																																																																			
	29.84	SS	Surface damage, spalling, from 10 to 12 o'clock	00:04:07			2																																																																																																
	39.96	JN	Junction, at 12 o'clock, diameter 375mm: CAPPED	00:05:18																																																																																																			
	58.72	JN	Junction, at 10 o'clock, diameter 150mm	00:08:15																																																																																																			
	59.94	F01 DEEJ	Attached deposits, encrustation at joint, from 7 to 5 o'clock, 5% cross-sectional area loss, End: PATCHY	00:09:52			2																																																																																																
	59.94	JN	Junction at 10 o'clock, diameter: 150mm: STEEL ROD THROUGH GULLY HOLDING DEBRIS BACK	00:10:04		5-1-11A																																																																																																	
	59.94	SA	Survey abandoned: NEEDS MORE CLEANING	00:10:10		5-1-12A

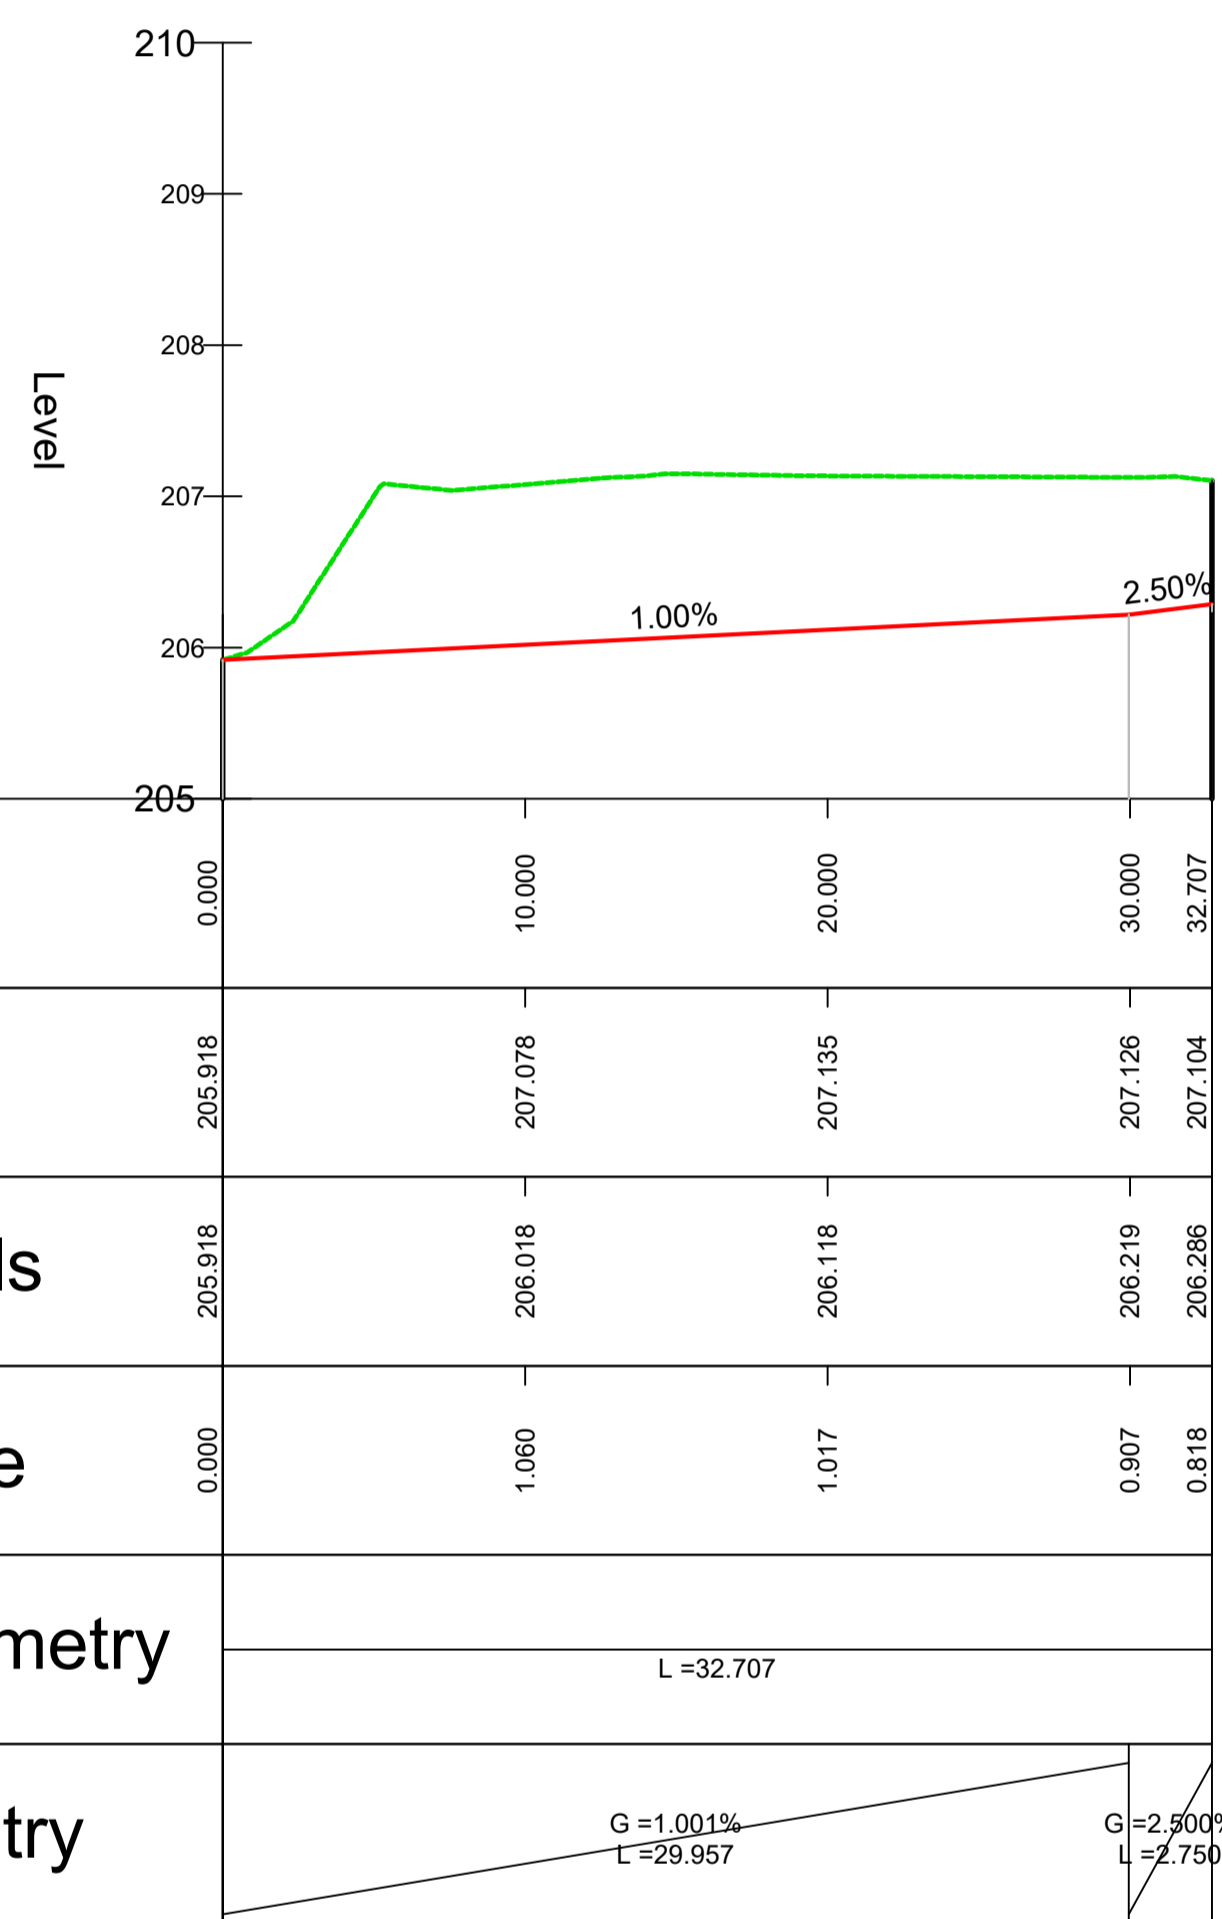
ROAD 1 - LONGSECTION
SCALE: H 1:250,V 1:50. DATUM: 205.000

Chainage	Existing Levels	Proposed Levels	Level Difference	Horizontal Geometry	Vertical Geometry
0.000	205.918	205.918	0.000	L = 32.707	G = 1.001% L = 29.957
10.000	207.078	206.018	1.060		
20.000	207.135	206.118	1.017		
30.000	207.126	206.219	0.907		
32.707	207.104	206.286	0.818		G = 2.500% L = 2.750

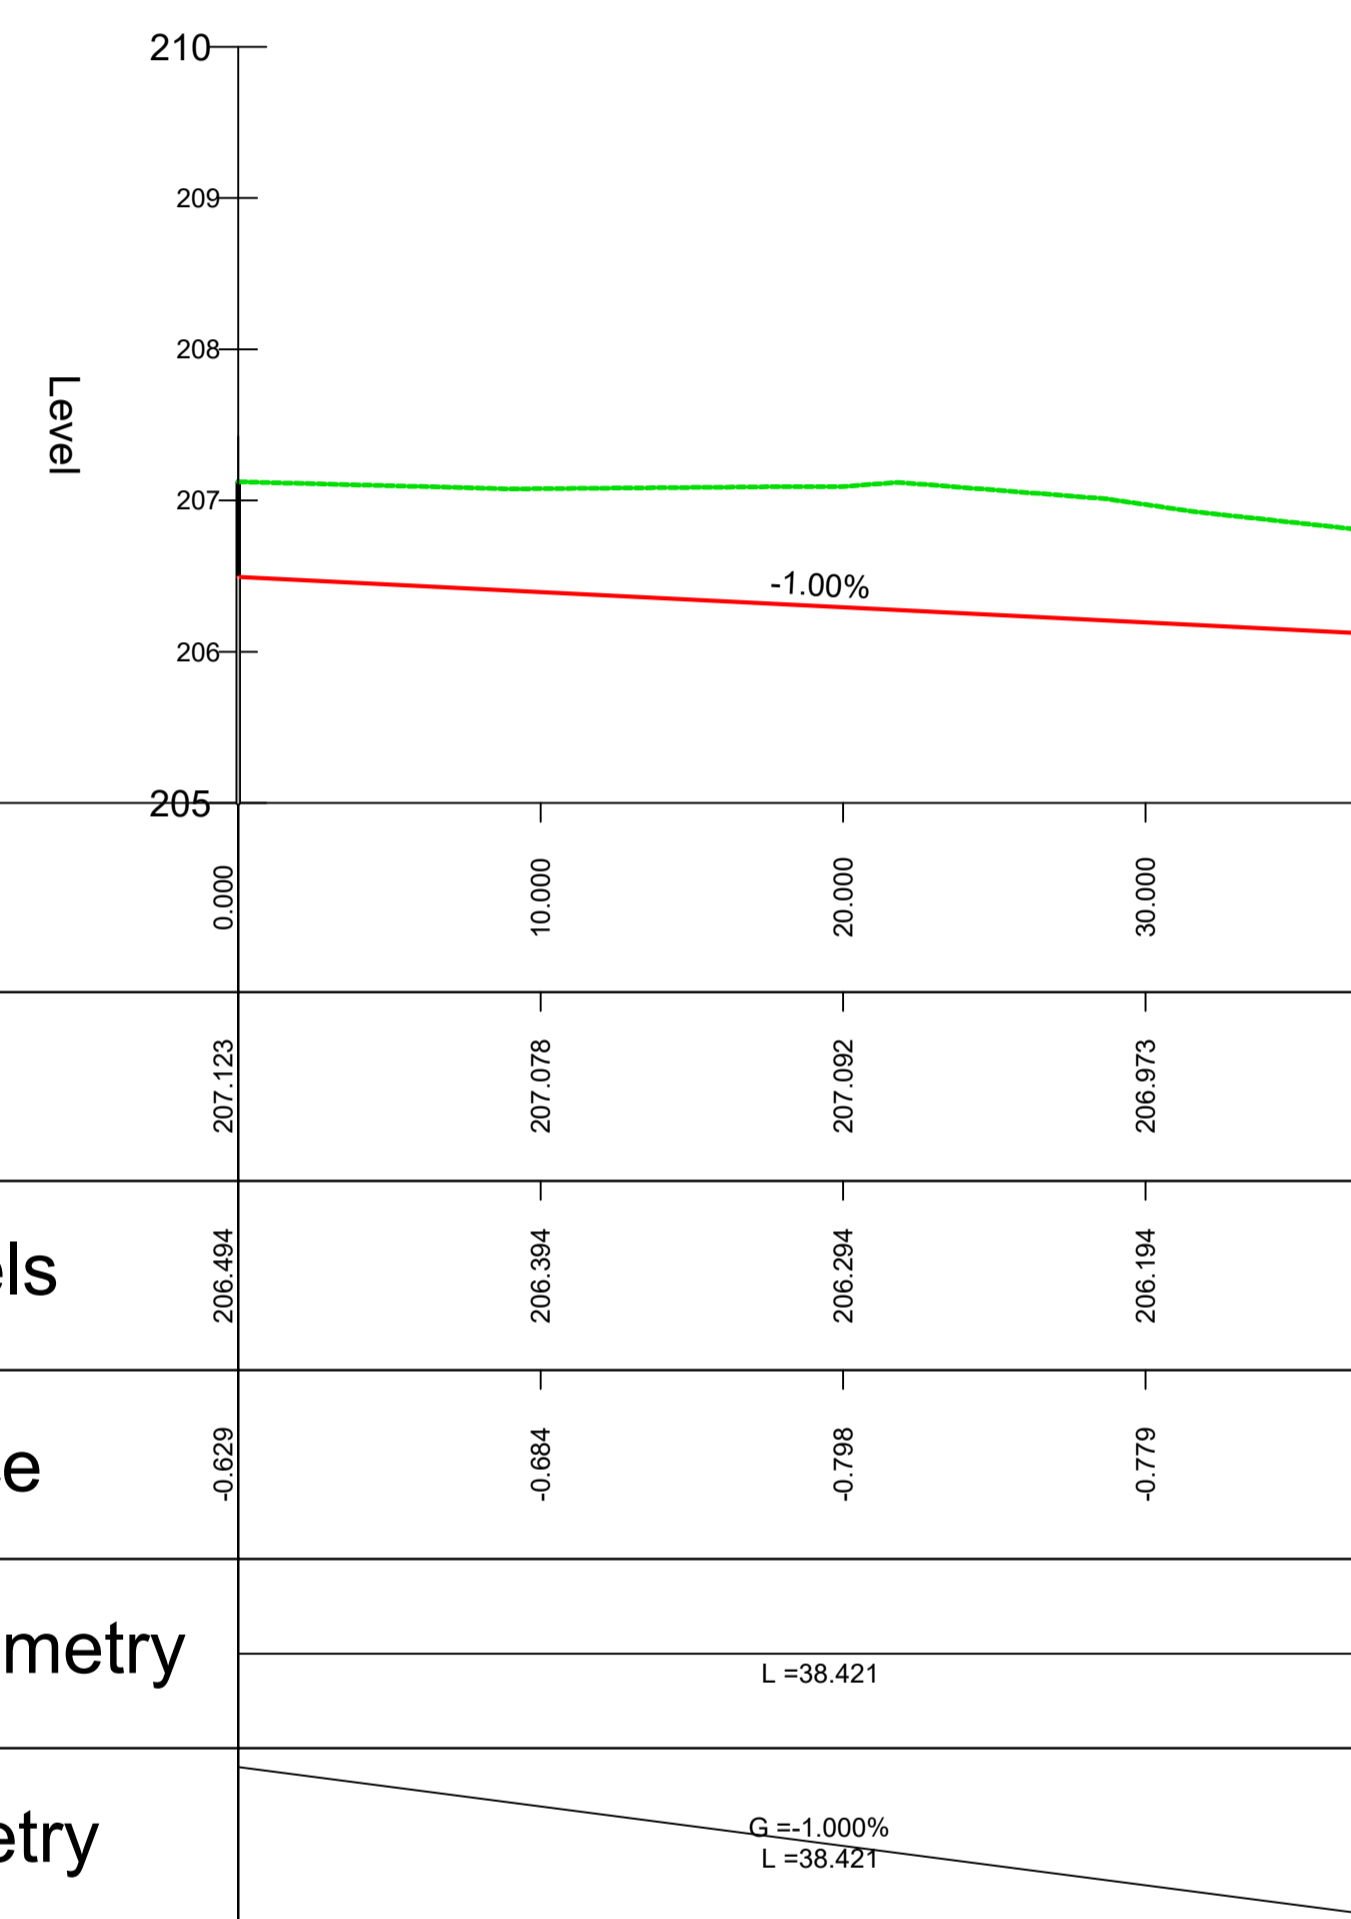
ROAD 2 - LONGSECTION
SCALE: H 1:250,V 1:50. DATUM: 205.000

Chainage	Existing Levels	Proposed Levels	Level Difference	Horizontal Geometry	Vertical Geometry
0.000	207.123	206.484	-0.629	L = 38.421	G = -1.000% L = 38.421
10.000	207.078	206.394	-0.684		
20.000	207.092	206.294	-0.798		
30.000	206.973	206.194	-0.779		
38.421	206.778	206.110	-0.668
