Former Tudor Inn – Cimla, Neath Proposed Residential Development Phase One Coal Mining Risk Assessment

Report Reference: ESP.8398.03.4163

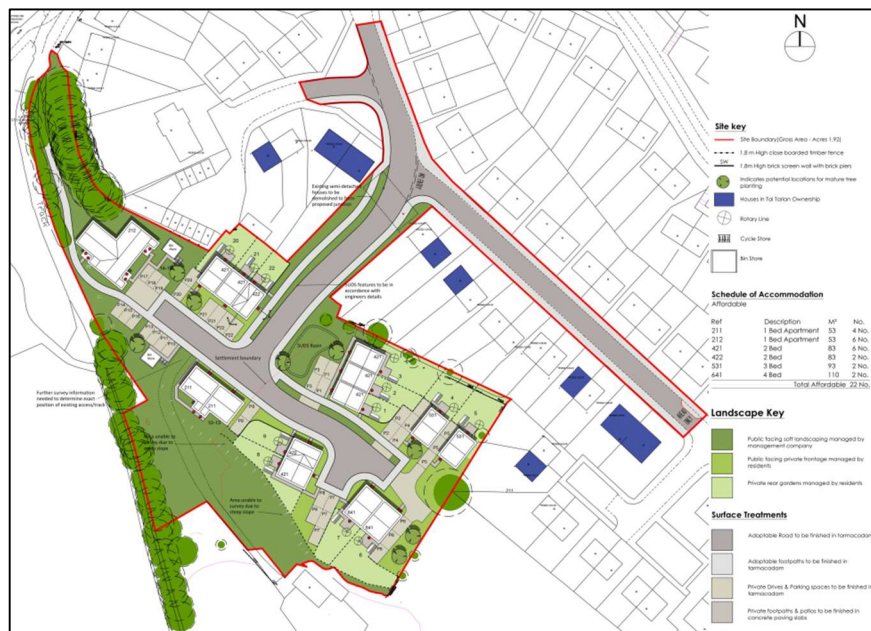
Insert 1 – Proposed Site Block Plan (Provided by Spring Design)

The proposed development will comprise conventional two-storey residential dwellings with private gardens, landscaping and estate roads. The proposed development layout is presented as Insert 1 below, and shows a large apartment block in the north-west, with link of three dwellings and six further residential structures around a central north-west to south-east orientated estate road. A new access road for the development will be constructed from Beacons View to the north-east, created by the demolition of existing properties. An infiltration basin (for SuDS) is shown just to the east of the new access.
