Bat Scoping Survey: Unit 6, Tafarnaubach Industrial Estate, Tredegar

Instructed by: Ron Skinner and Sons

Reported by: Ecological Services Ltd 10 Mount Pleasant, Llanelly Hill, Abergavenny, Monmouthshire, NP7 0NT

Author	Date	Version
Richard Watkins	October 2024	V1.0

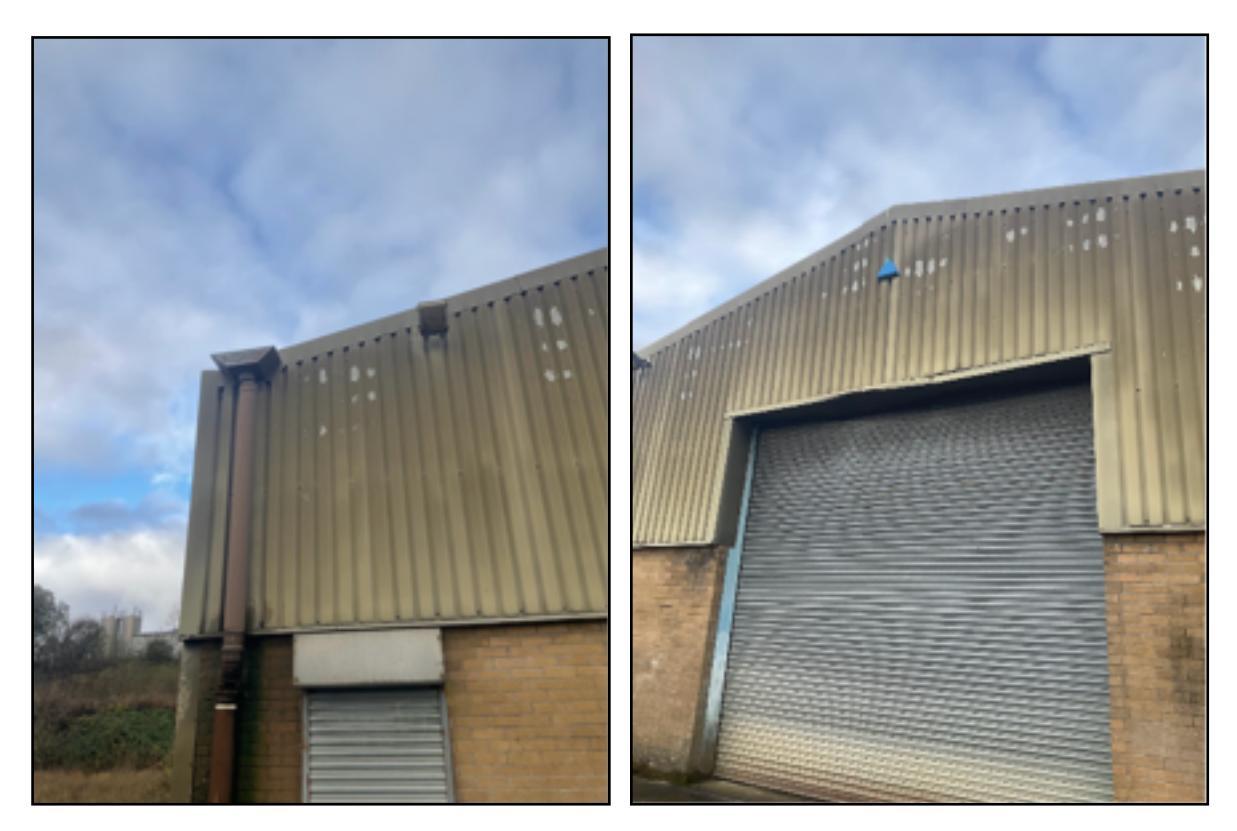
Unit 6, Tredegar

6.3 Due to the age and condition of the building, there were a limited number of opportunities present for bats to access and use the building and those that were available were deemed as having negligible potential for roosting bats. In general, the building appeared well sealed. Potential gaps were noted around the metal cladding. However, these gaps are considered to have limited suitability as bats could not gain purchase on the metal cladding to climb into the features. Given the metal construction of the roof, it is considered highly unlikely that bats could utilise any possible gaps for roosting purposes as they cannot gain purchase on such material.

6.4 No droppings or evidence of bats were discovered on any external features.

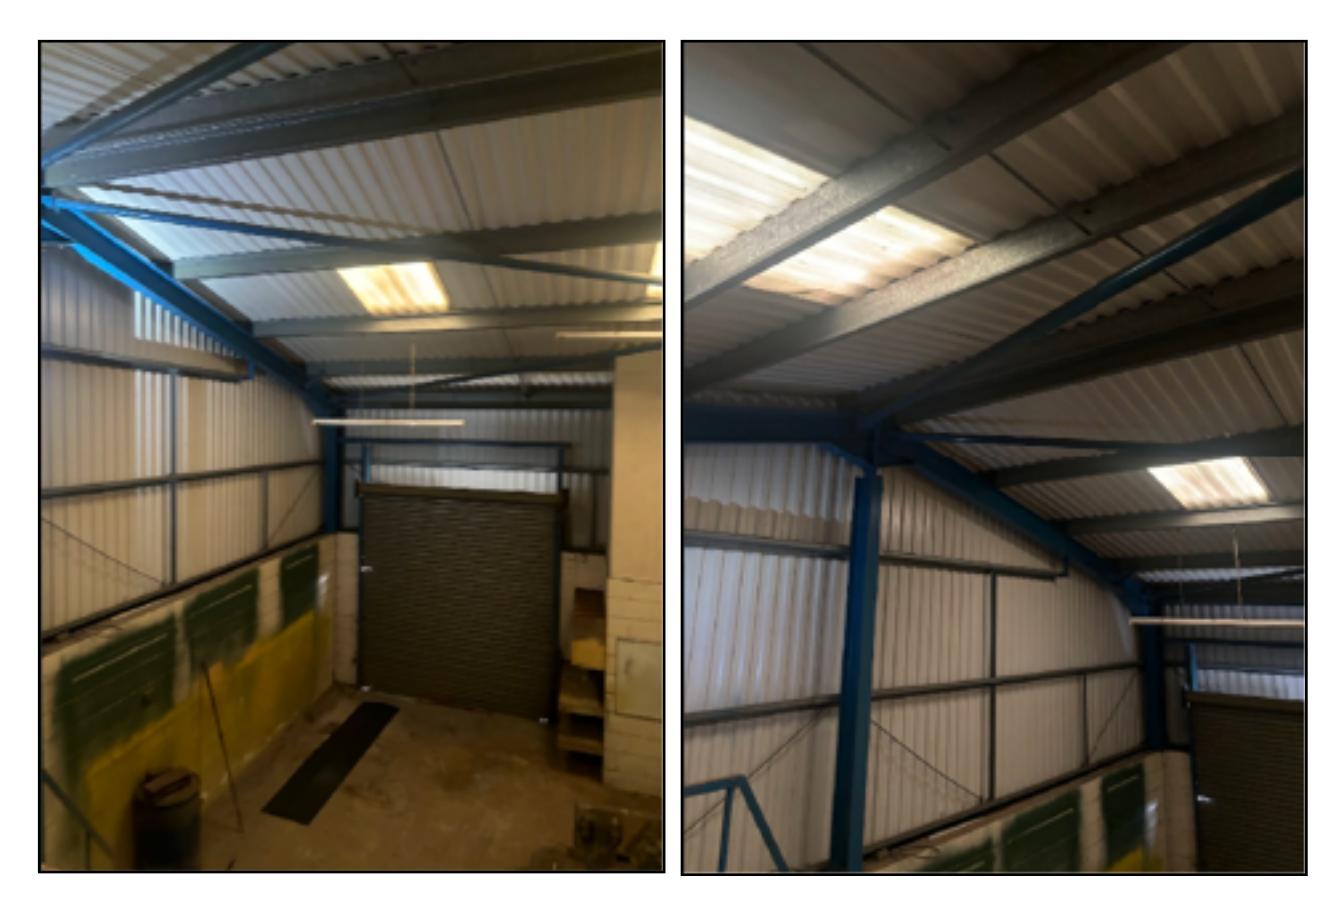
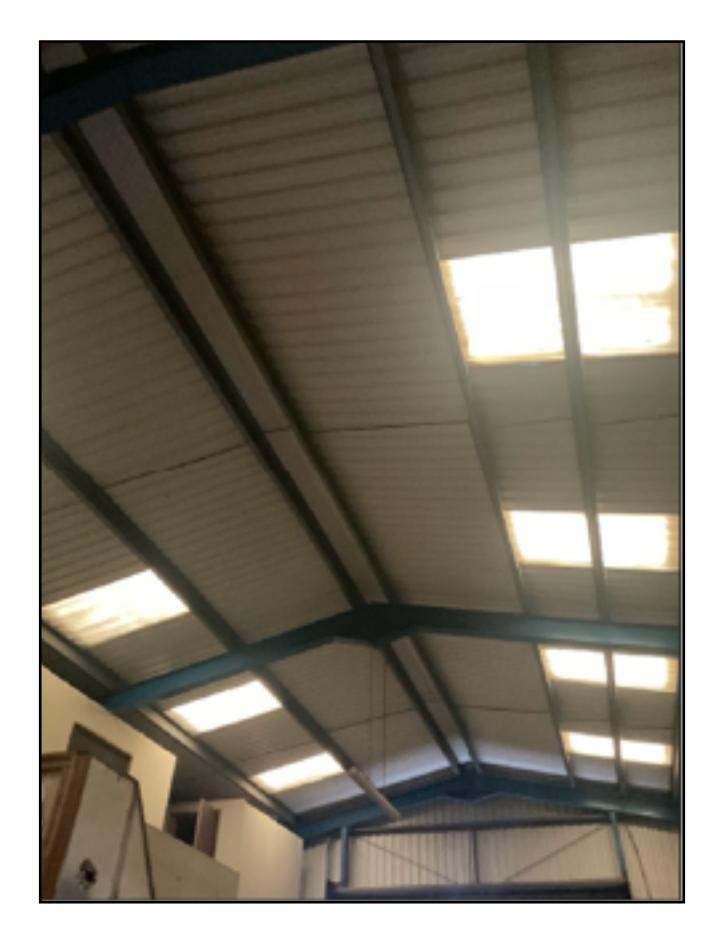
7.2 There was no internal attic space within the building. The building is open to the roof and comprises an open workshop area and wooden built offices.

7.3 No droppings or evidence of bats were discovered on any internal features.
